Glasgow City Council – Neighbourhoods and Sustainability

Cycle Lane Soft Segregation Trial Report

FEBRUARY 2020

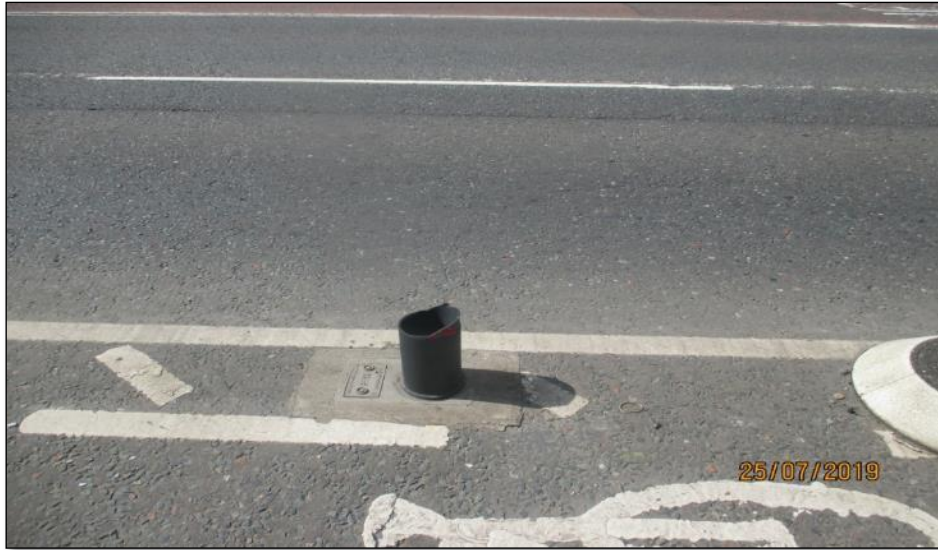
A total of 15 units were observed. This number coincides with the number of units originally installed. 2 bollards were damaged (refer to figure 8 & 9) and 13 were found to be in good conditions (refer to figure 10) as shown in the graph below, (refer to figure 7 and table 2).

Figure 8: damaged bollard on Aikenhead Road.

For further installation of Bollards it is recommended for the products to be resin in rather than bolted.

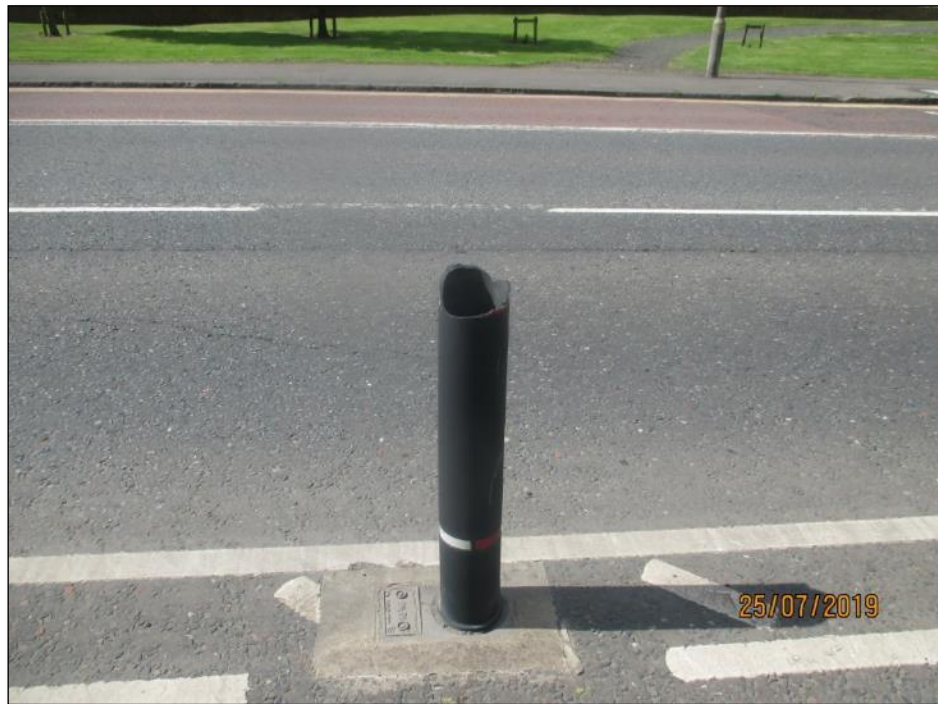
Figure 9: damaged bollard on Aikenhead Road.

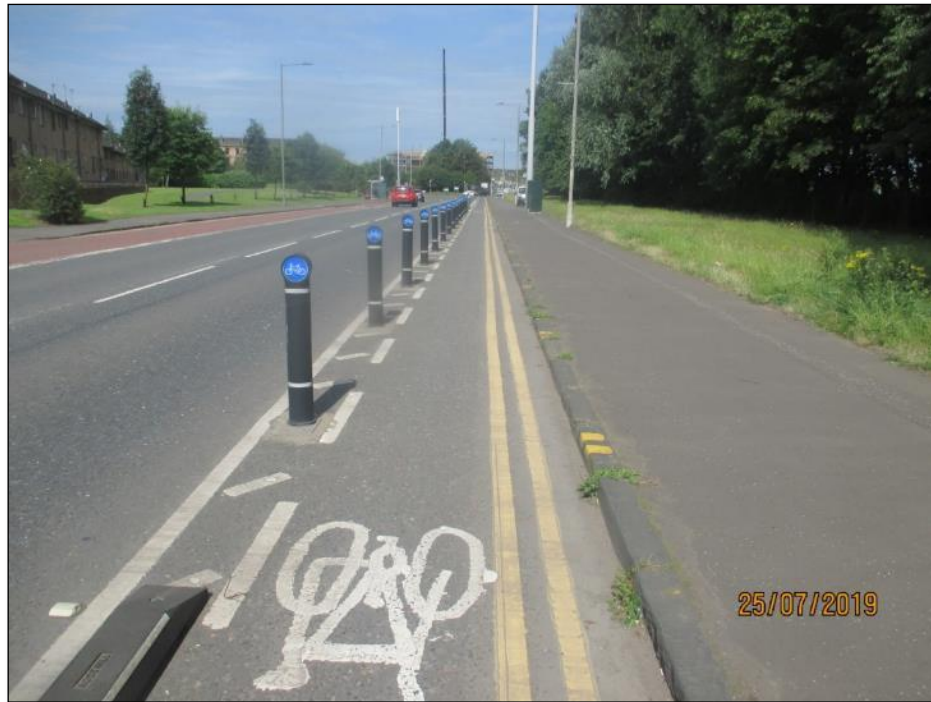
Figure 10: bollards in good conditions on Aikenhead Road.

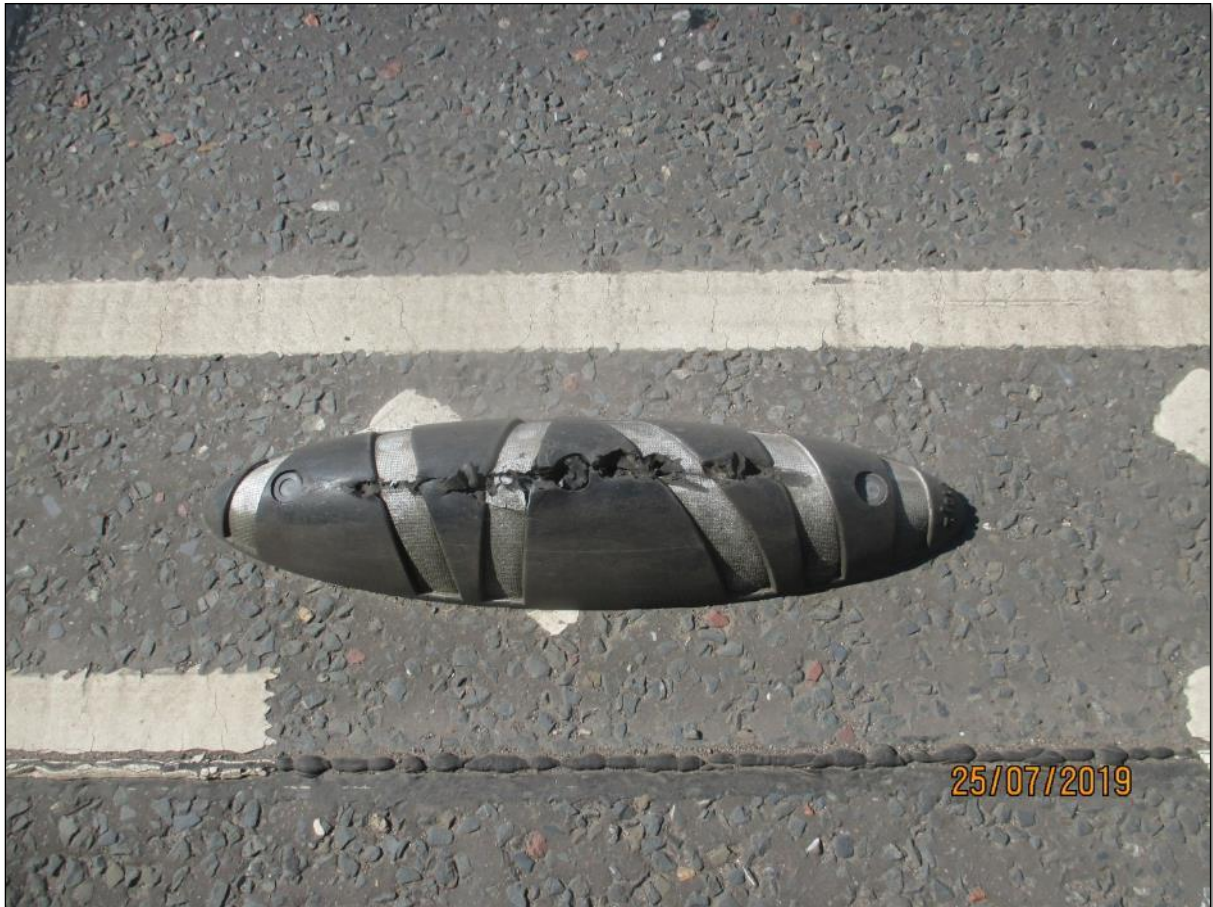
A total of 30 units were observed. This number coincides with the number of units installed. All Armadillos are intact but 4 Armadillos (refer to figures 12 & 13), showed signs of damage mainly to the top/surface area. 16 units were found to be slightly damaged (refer to figure 14), showing signs of discolouration.

Figure 12: example of damaged Armadillo on Aikenhead Road.

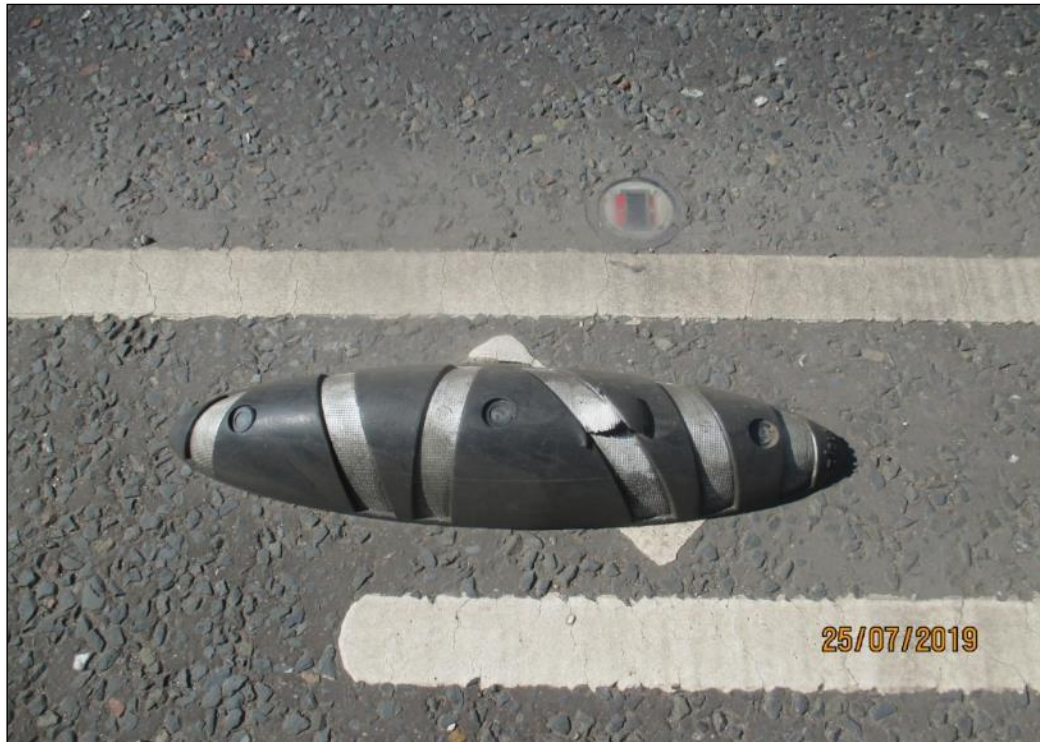
Figure 13: example of damaged Armadillo on Aikenhead Road.

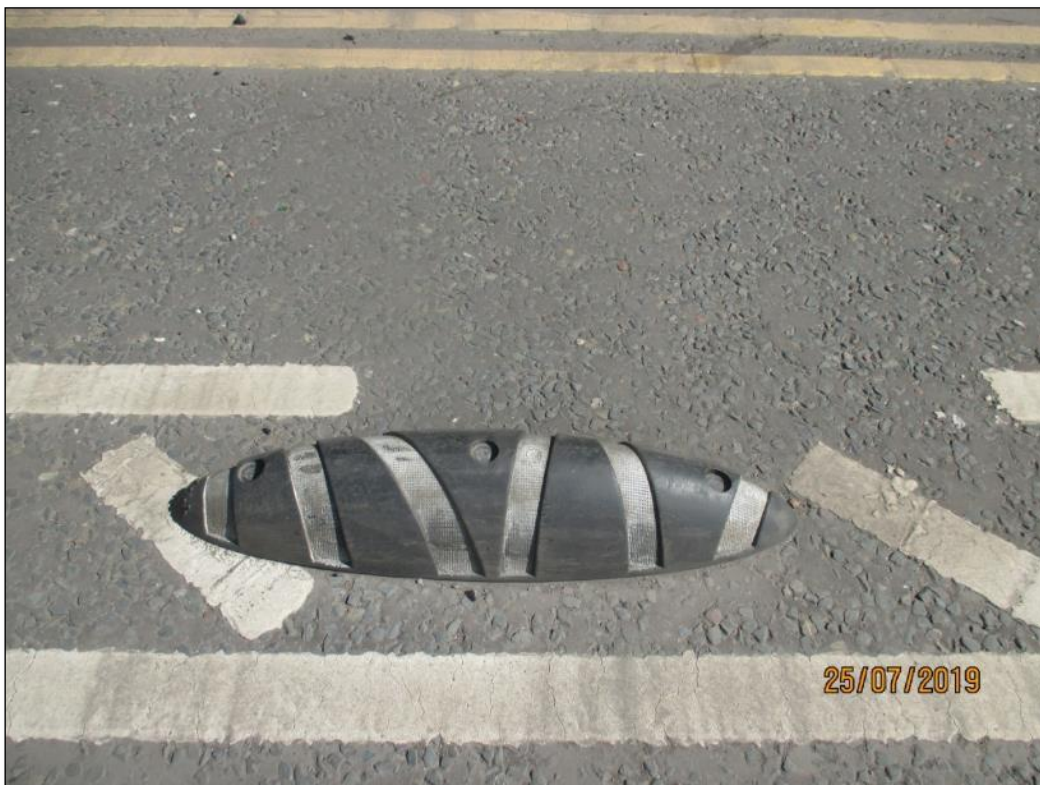
Figure 14: Armadillo defender showing signs of discolouration within reflective area on Aikenhead Road.

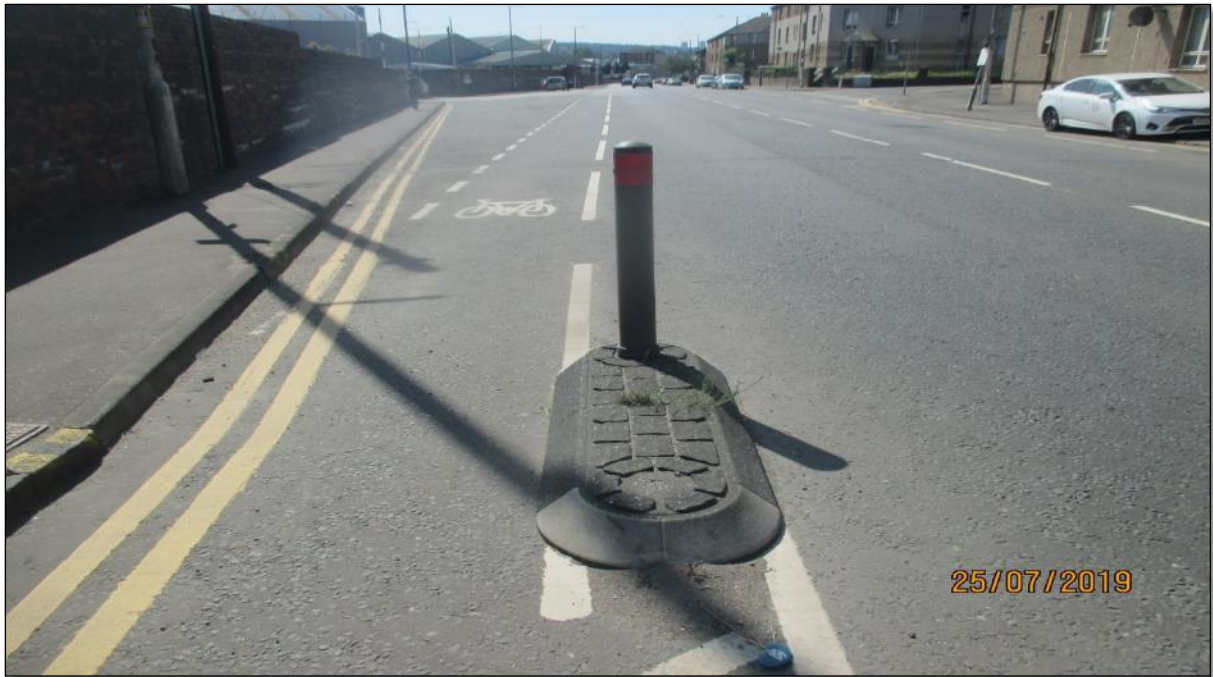
A total of 4 units were observed. This number coincides with the number of units originally installed. 3 out of 4 dividing islands are intact and 1 island (refer to figure 16) was missing. 3 units were found to be in good conditions (refer to figure 17).

Figure 16: dividing island with missing bollard on Aikenhead Road.

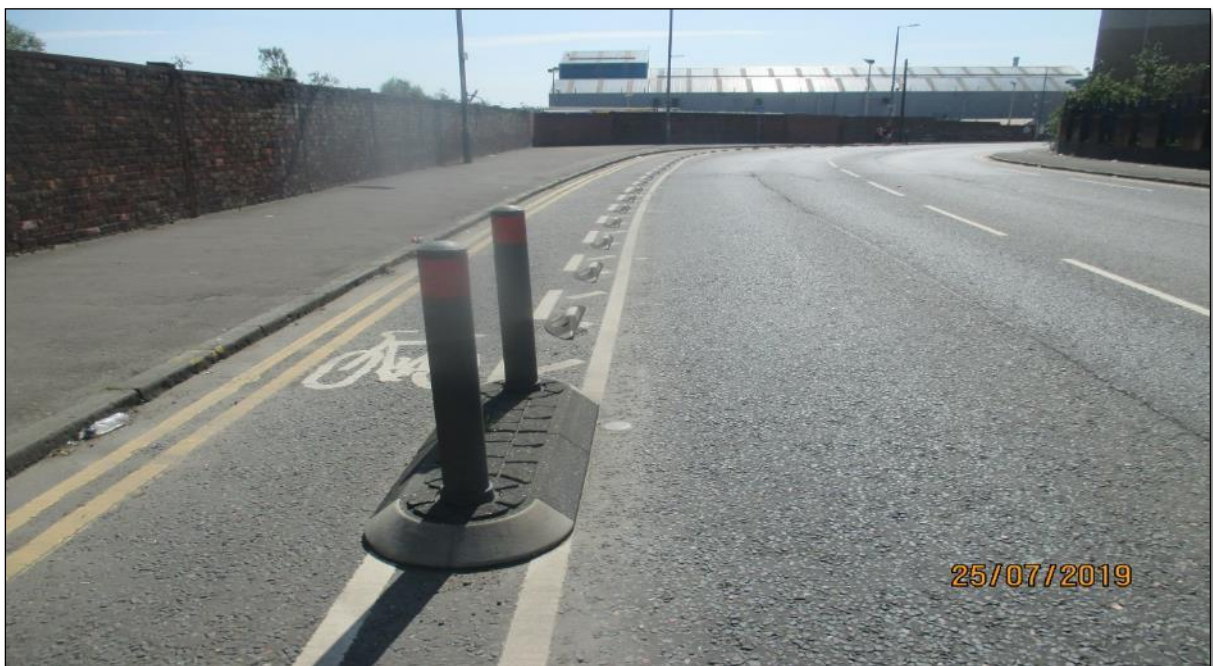
Figure 17: example of dividing island in good conditions on Aikenhead Road.

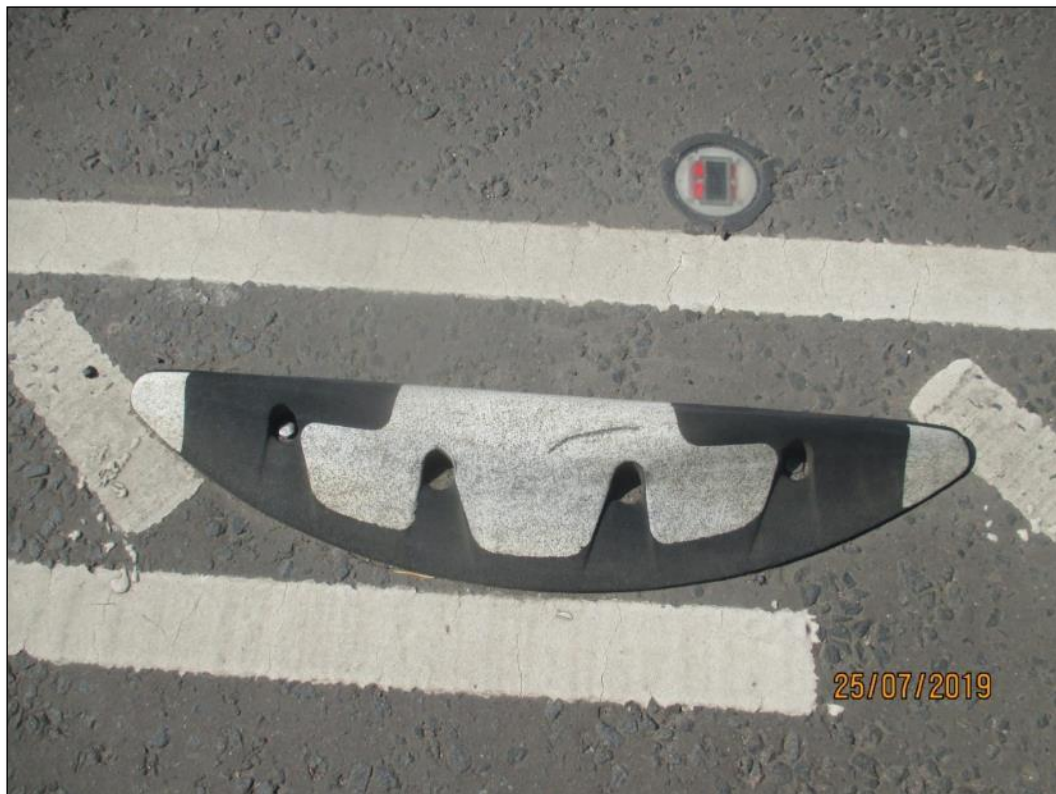
A total of 30 units were observed. This number coincides with the number of units originally installed. All Orcas are intact. One Orca was found to be showing signs of minor damage (refer to figure 19) and all remaining 29 units were found to be in good conditions (refer to figure 20).

Figure 19: Orca showing signs of minor damage on Aikenhead Road.

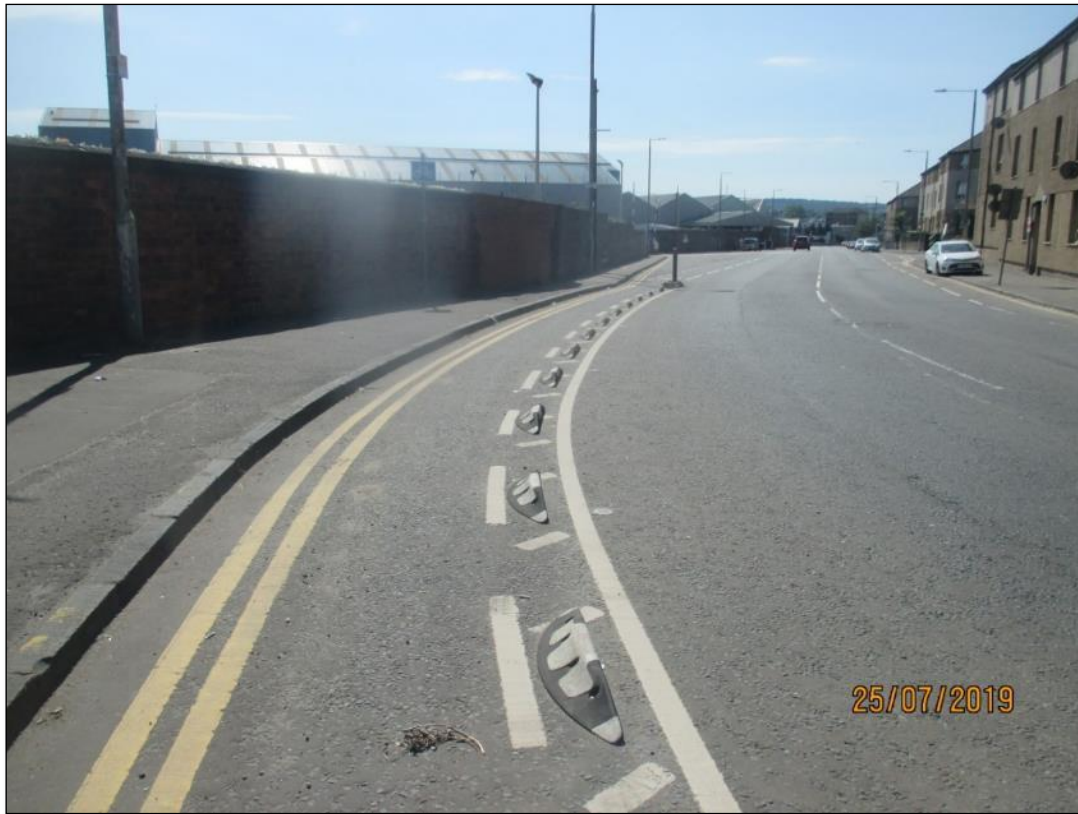
Figure 20: example of Orcas in good conditions on Aikenhead Road.

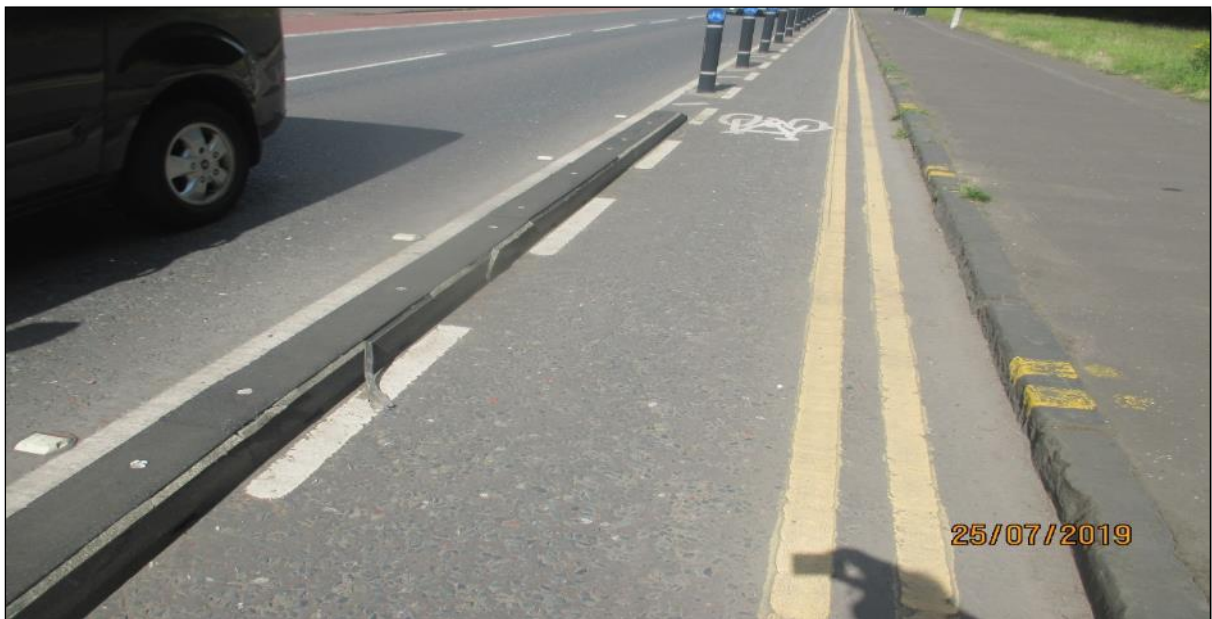
A total of 26 units were observed. This number coincides with the number of units originally installed. All Defenders are intact, however the reflective strip on all 26 units has or is in the process of peeling off, this seems to be happening mainly on the side of the cycle lane. All weepers appeared to be blocked with debris/silt. 9 units were found to be showing signs of major damage attributable to impact and all remaining 17 units showed signs of minor damage (refer to figure 22).

Figure 22: example of Cycle Lane Defenders showing slight damage due to reflective strip peeling off.

- Blocking of weep holes in Orcas, Defenders and Armadillos due to accumulation of debris and/or slit;
- Regular cleansing of Orcas and Armadillos to clean darkened surfaces;
- Regular replacement of reflective strips on cycle lanes Defenders; and
- Regular inspections to check loose or missing bolts and broken or missing units.

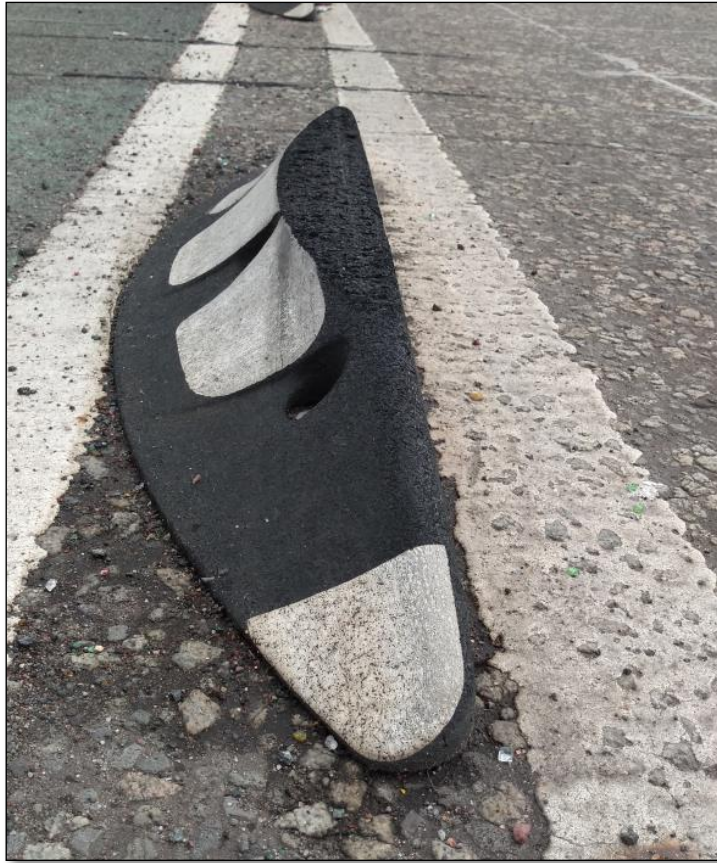
A total of 52 units were observed, (refer to figure 24). 53 units were originally installed. 40 Orcas were found to be showing signs of slight damage (refer to figure 25), 12 units were found to be showing signs of major damage, mainly to the top surface area, (refer to figure 26) and 1 unit was missing, (refer to figure 27).

Figure 26: example of major damage to Orca on Glasgow Bridge.

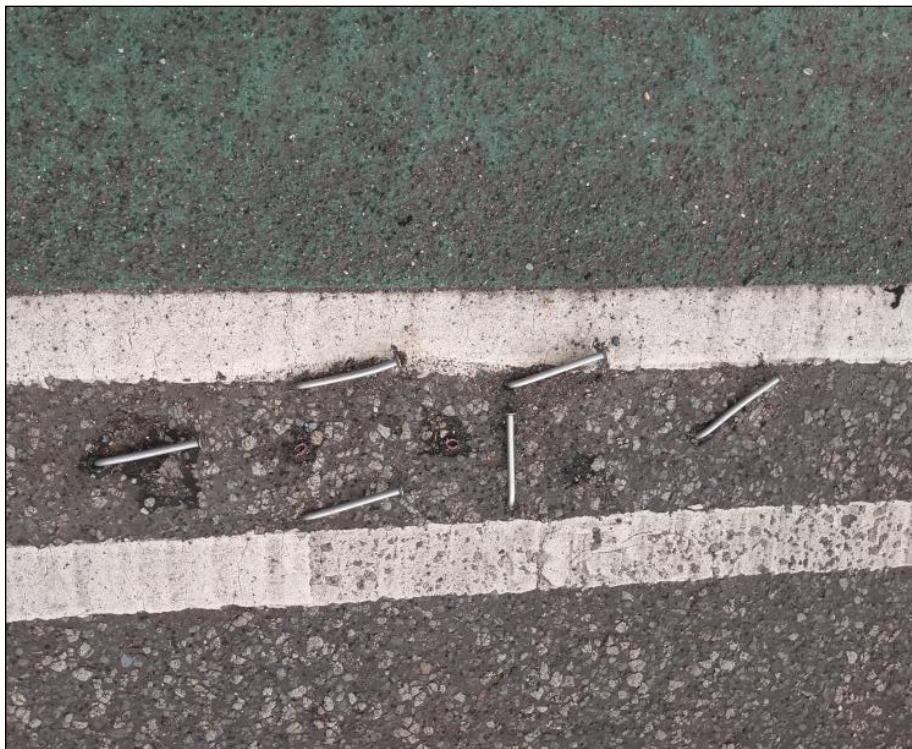
Figure 27: missing Orca on Glasgow Bridge.

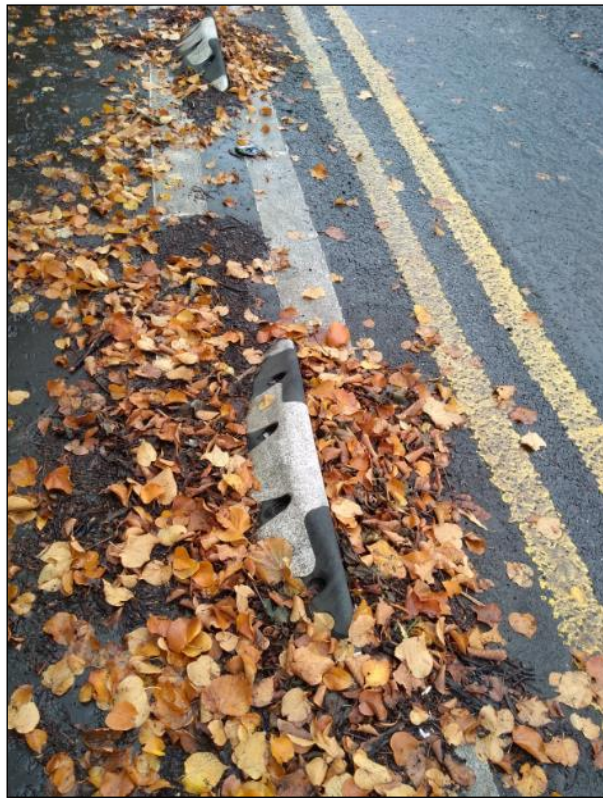
A total of 381 units were observed. 382 Orcas were originally installed. The vast majority of weepers appeared to be blocked with debris/silt, (refer to figure 29). 176 units were found to be showing signs of minor damage; this included slight or moderate levels of darkened surfaces (refer to figure 30), and tyre marks on the units. Darkened Orcas were observed predominantly under wide-leaf trees, possibly due to limited exposure to sunlight and subsequent effects of increased humidity. 10 Orcas were found to be showing signs of major damage (refer to figure 31); including damage to the top surface, loose or missing bolts and extremely darkened surface (refer to figure 32). 1 Orca was found to be missing on Dyke Road. 195 units were found to be in good conditions.

Figure 29: example of weepers blocked by debris/slit along the routes to Knightswood Park.

It is recommended to investigate means to cleanse the surface of Orcas especially those installed under trees and to include the Routes to Knightswood in GCC's new Multihog 'Cleansing and de-icing' programme in order to remove foliage from the cycleway which increase blockage of weep holes on soft segregation products.

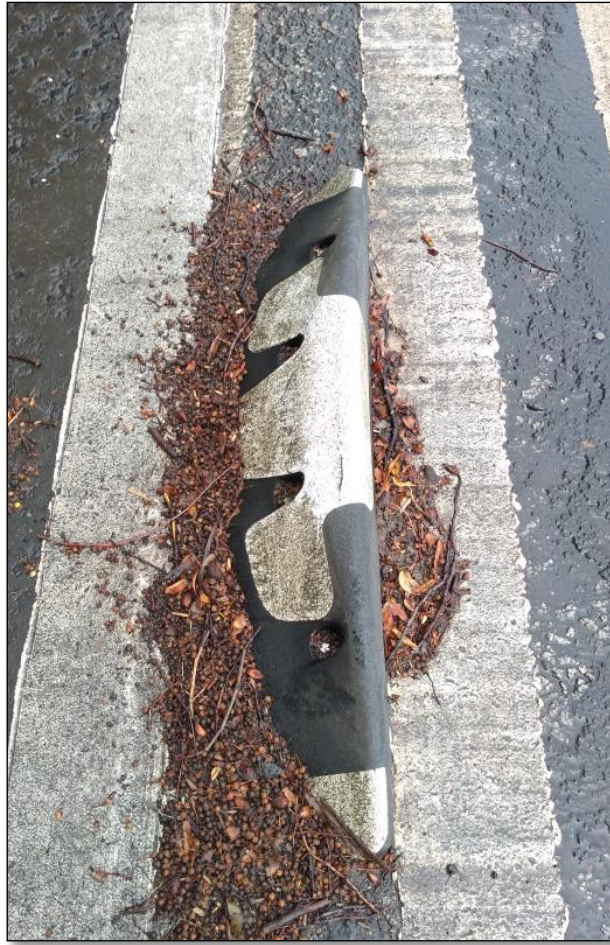
Figure 30: example of moderate darkening of Orcas' surface along the routes to Knightwood Park.

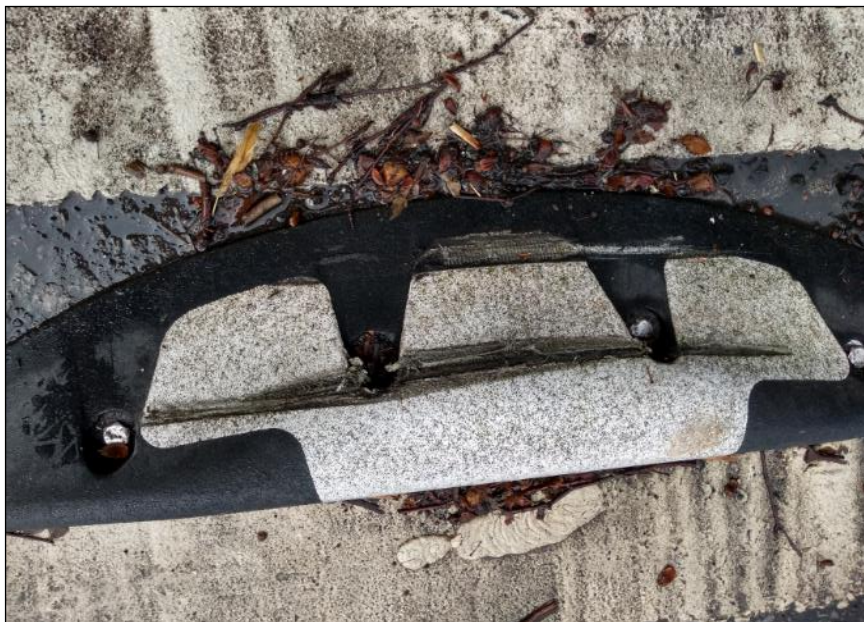
Figure 31: example of Orcas showing major damage to the top surface along the routes to Knightwood Park.

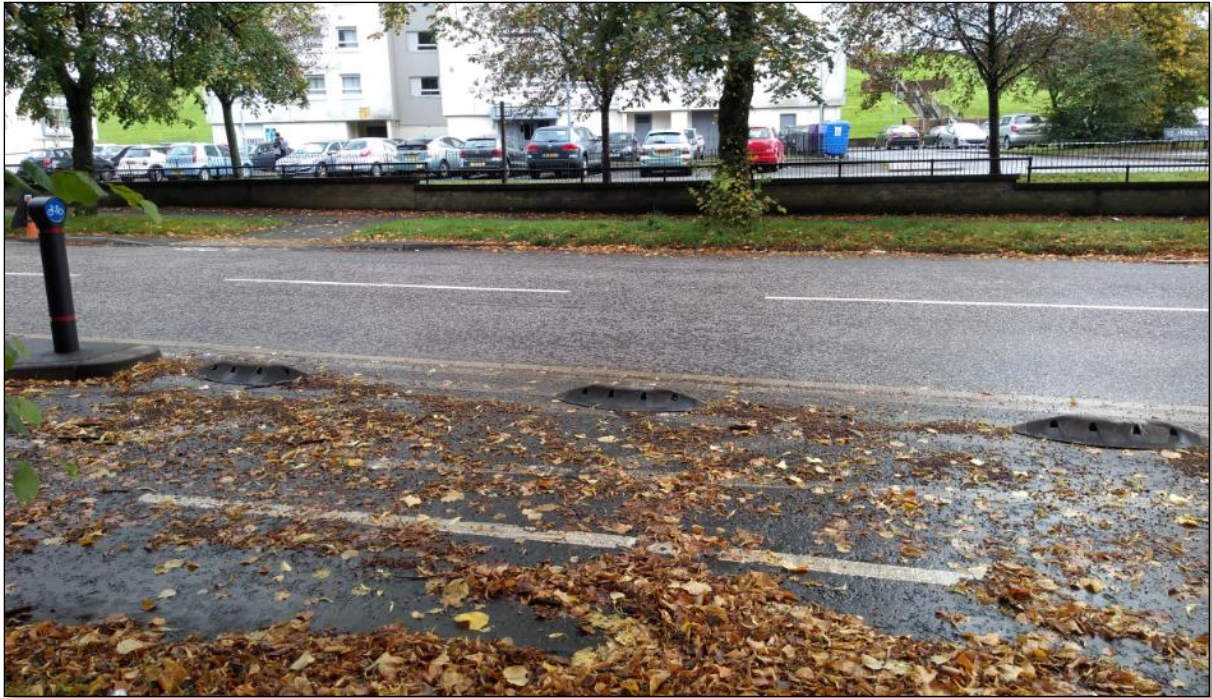
Figure 32: example of Orcas showing major damage due to extremely darkened surface along the routes to Knightswood Park.

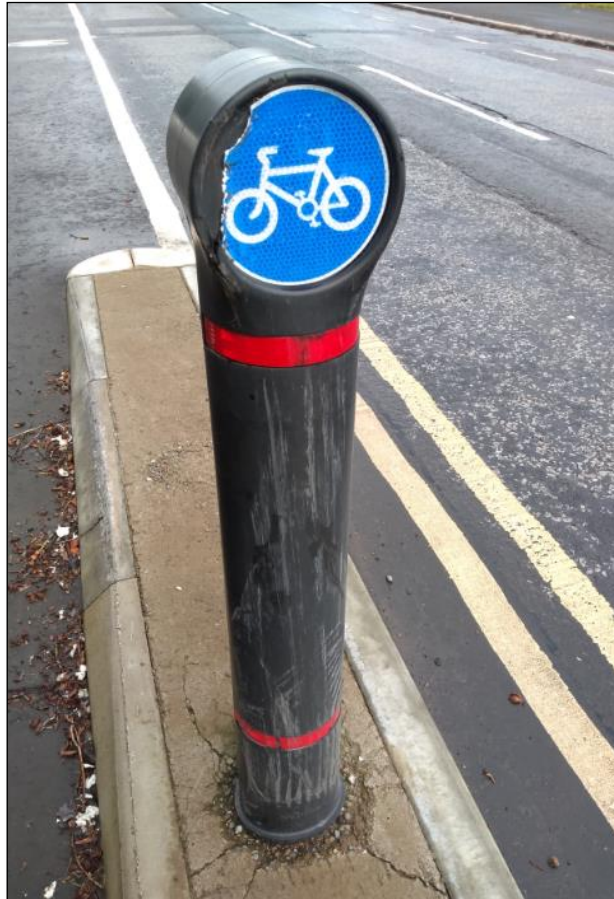
A total of 26 units were observed. This number coincides with the number of units originally installed. 2 bollards were damaged (refer to figures 34 & 35), 2 units were slightly damaged (refer to figure 36) and 22 bollards were found to be in good conditions (refer to figure 37).

Figure 34: damaged bollard along the routes to Knightswood Park - Dyke Road.

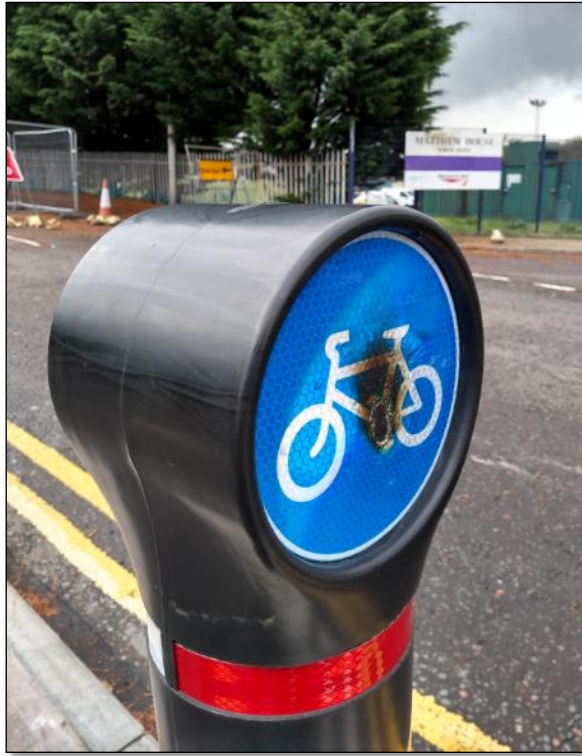
Figure 35: damaged bollard presenting signs of vandalism along the routes to Knightswood Park - Dyke Road.

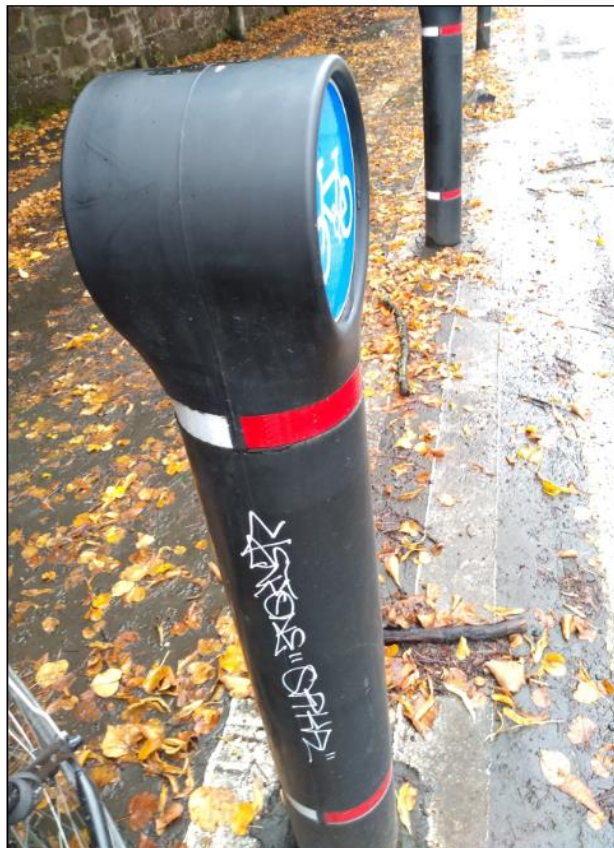
Figure 36: slightly damaged bollard showing signs of vandalism as observed along the routes to Knightswood Park - Dyke Road.

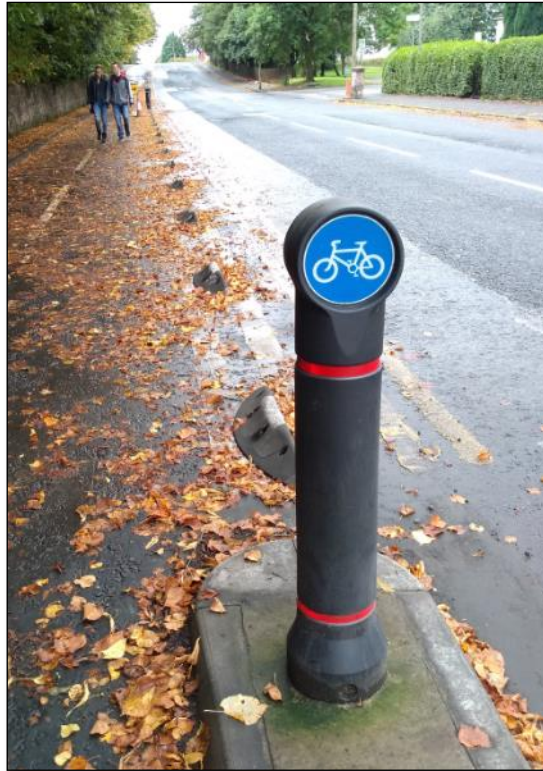
Figure 37: example of bollard in good conditions as observed along the routes to Knightswood Park - Dyke Road.

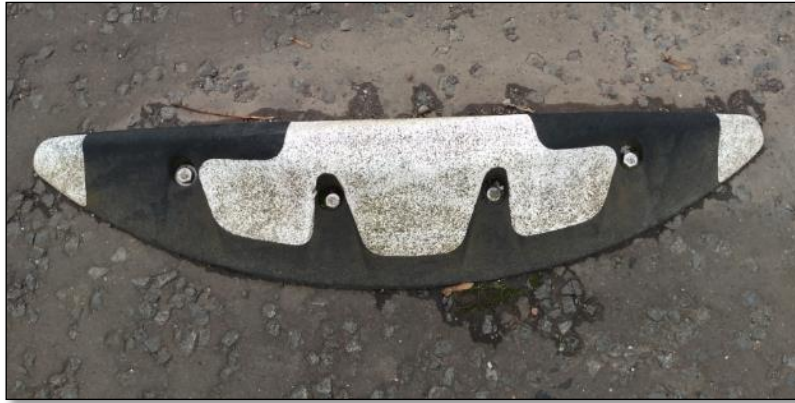
Figure 40: example of minor damage due to Orca on the River Clyde South Bank Route due to darkened surface.

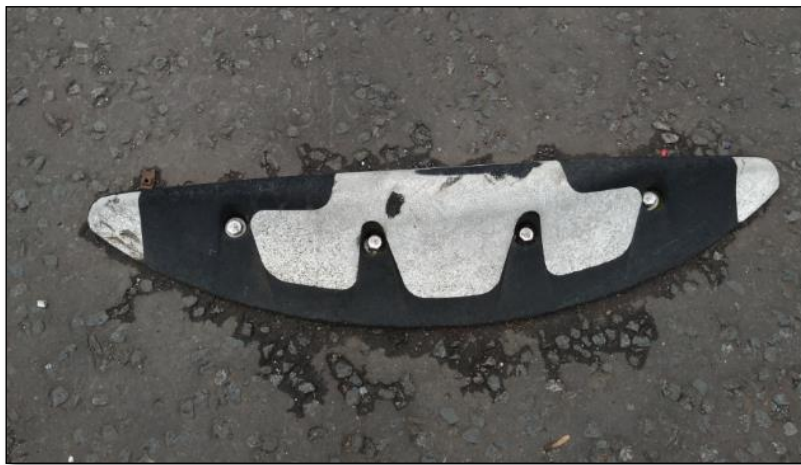
Figure 41: example of major damage to Orca on the River Clyde South Bank Route.

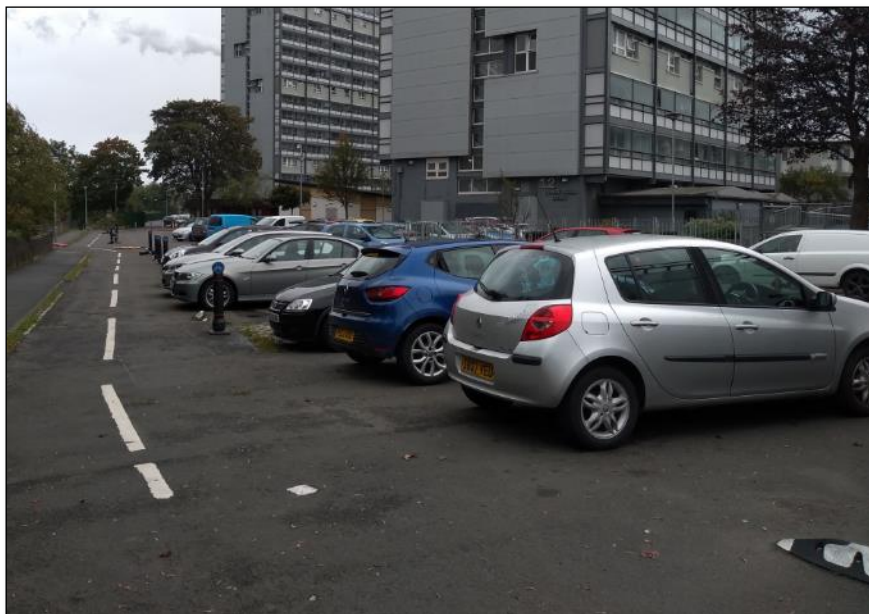
Figure 42: example of missing Orcas on the River Clyde South Bank Route.

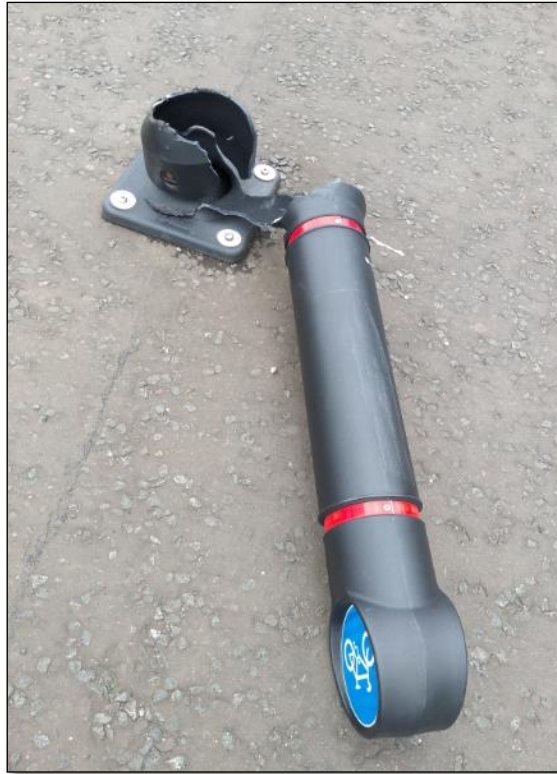
A total of 17 units were observed. 23 units were originally installed. 11 bollards were damaged (refer to figure 44); including displaced bollards and units with loose or missing bolts, (refer to figure 45). 6 units were missing, 1 unit was slightly damaged and 5 bollards were found to be in good conditions (refer to figure 46).

Figure 44: example of damaged bollard on the River Clyde South Bank Route.

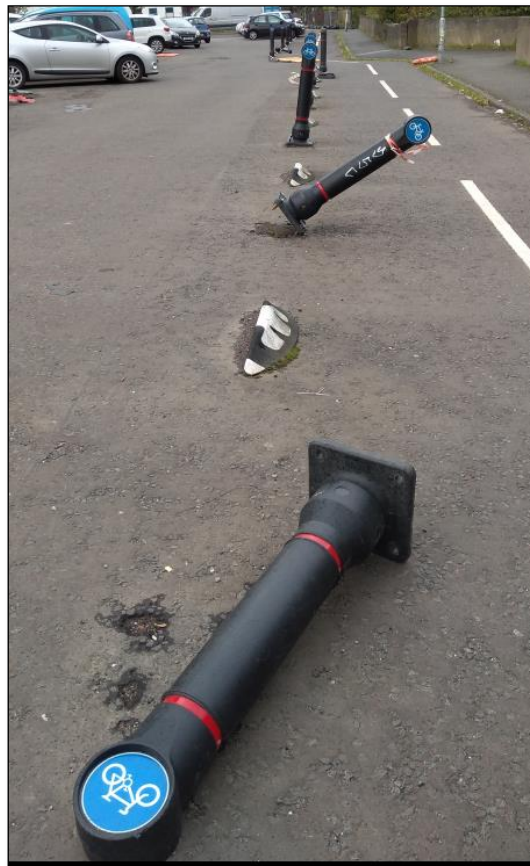
Figure 45: example of a displaced bollard and a unit with loose/missing bolts on the River Clyde South Bank Route.

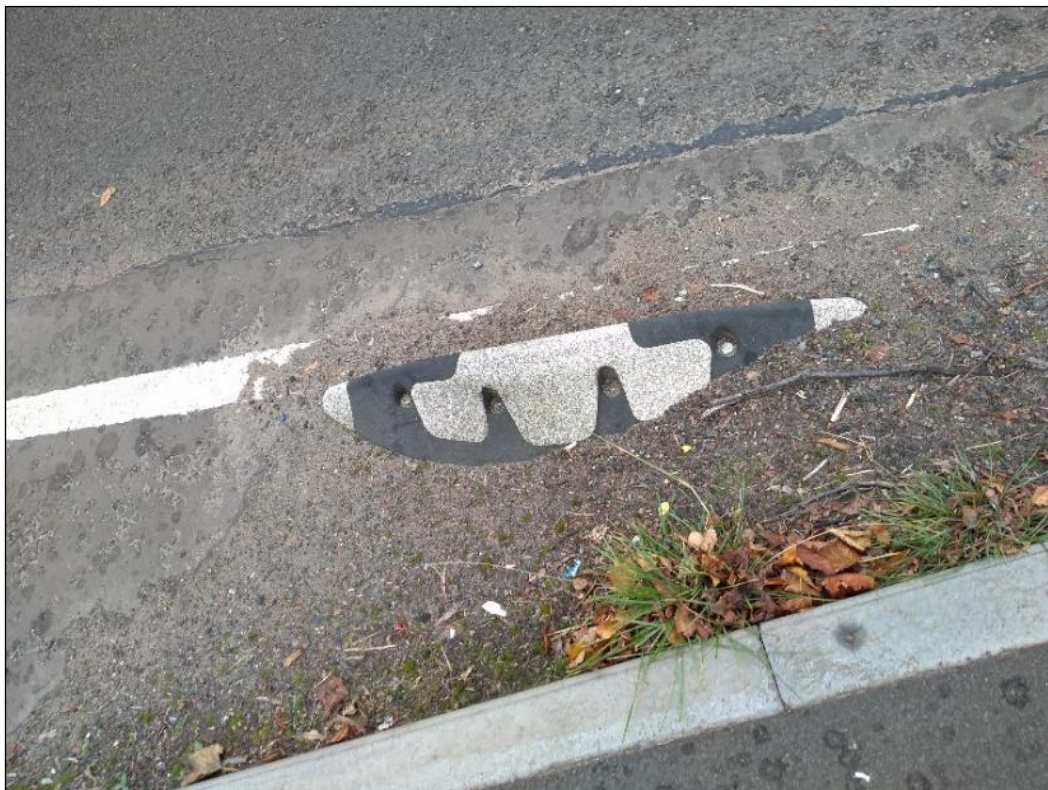
A total of 209 Orcas were observed. This number coincides with the number of units originally installed. The vast majority of weepers appeared to be blocked with debris/silt, (refer to figure 48). 74 units were found to be showing signs of minor damage; this included slight or moderate levels of darkened surfaces and tyre marks on the unit (refer to figure 49). 5 Orcas were found to be showing signs of major damage; including damage to the top surface, extreme darkening and loose or missing bolts (refer to figure 50). 130 Orcas were found to be in good conditions.

Figure 48: example of Orca's weepers blocked by debris/slit on Wallacewell Road.

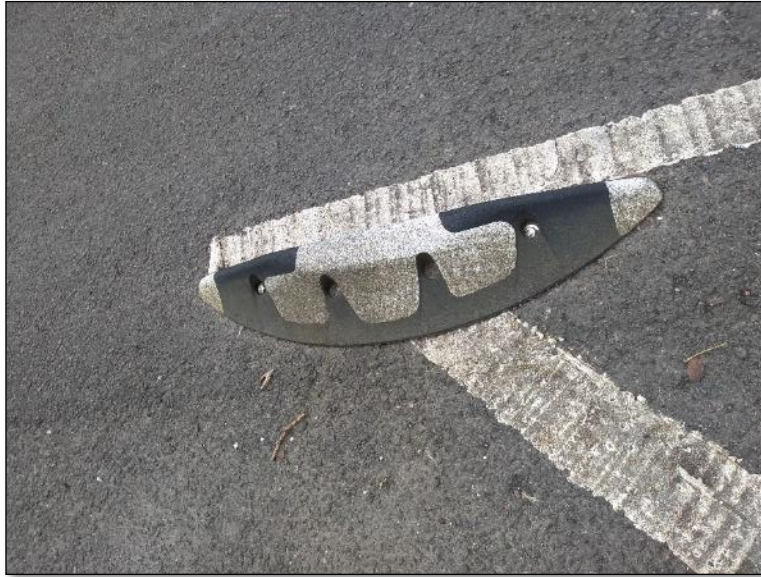
Figure 49: example of Orca's slight damage due to the unit's darkened surface as observed on Wallacewell Road.

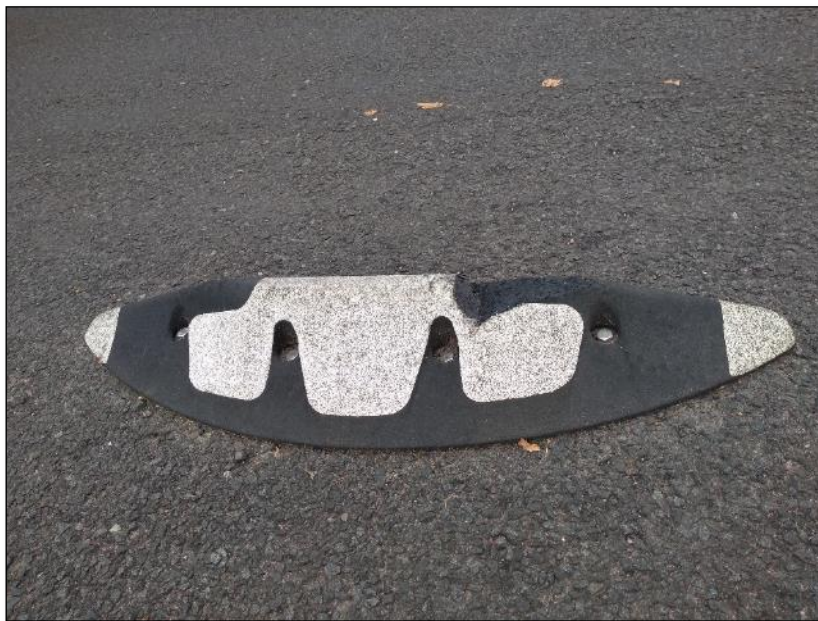
Figure 50: example of damaged Orca on Wallacewell Road.

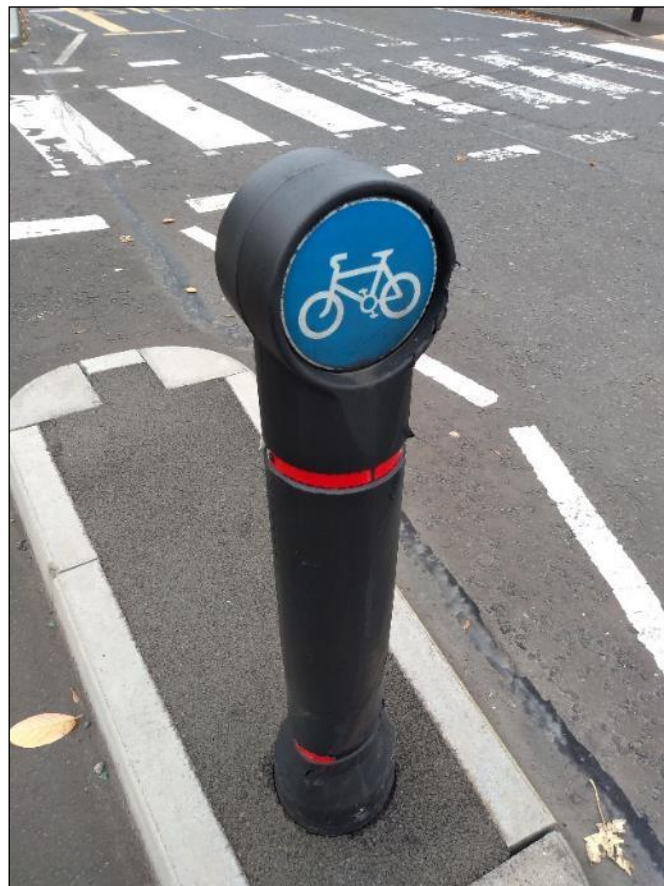
A total of 12 units were observed. This number coincides with the number of units originally installed. 1 bollard was damaged (refer to figure 52) and 11 bollards were found to be in good conditions.

Figure 52: damaged bollard on Wallacewell Road.

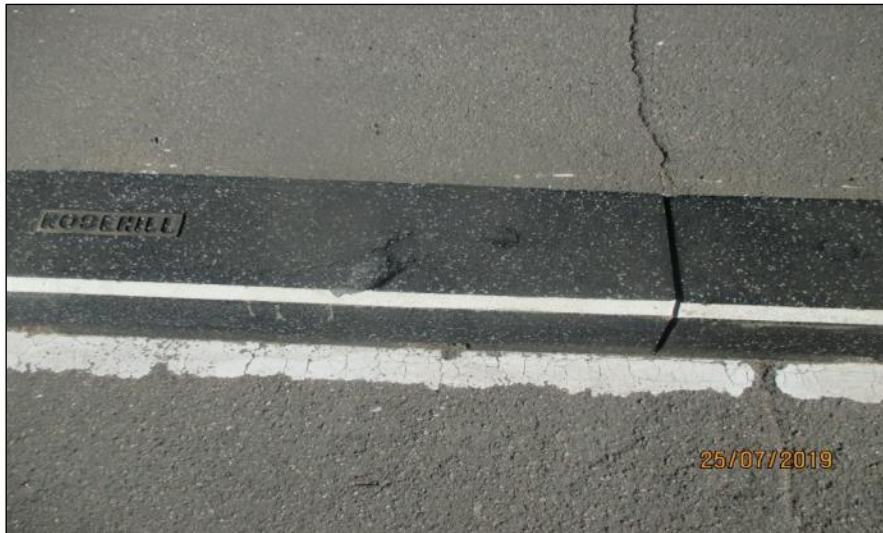
A total of 11 units were observed. This number coincides with the number of units originally installed. 4 Defenders were damaged (refer to figure 54) and 7 Defenders were found to be slightly damaged (refer to figure 55), mainly as a consequence of the reflective strips peeling off and minor deterioration to the surface due to impact.

Figure 54: example of damaged Defender on Berkeley Street.

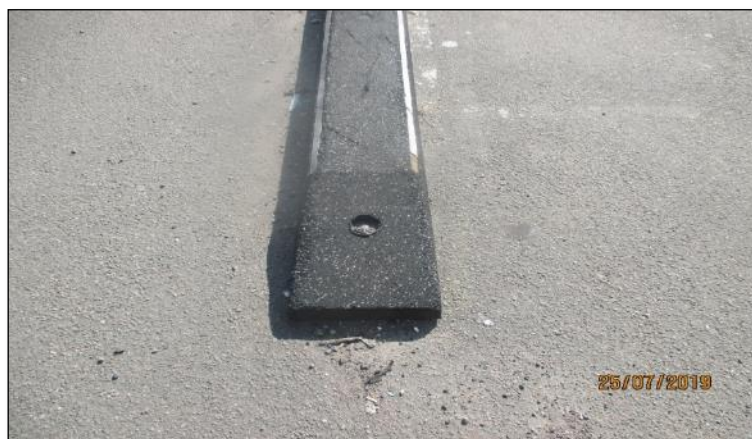
Figure 55: cycle lane Defender on Berkeley Street showing signs of minor damage.
