TREE INSPECTION REPORT AND WOODLAND MANAGEMENT RECOMMENDATIONS: THE CHILDREN'S WOOD, NORTH KELVIN, GLASGOW

**Prepared for The Children's Wood
January 2016**

**TREE INSPECTION REPORT, THE CHILDREN'S WOOD, NORTH KELVIN,
GLASGOW**

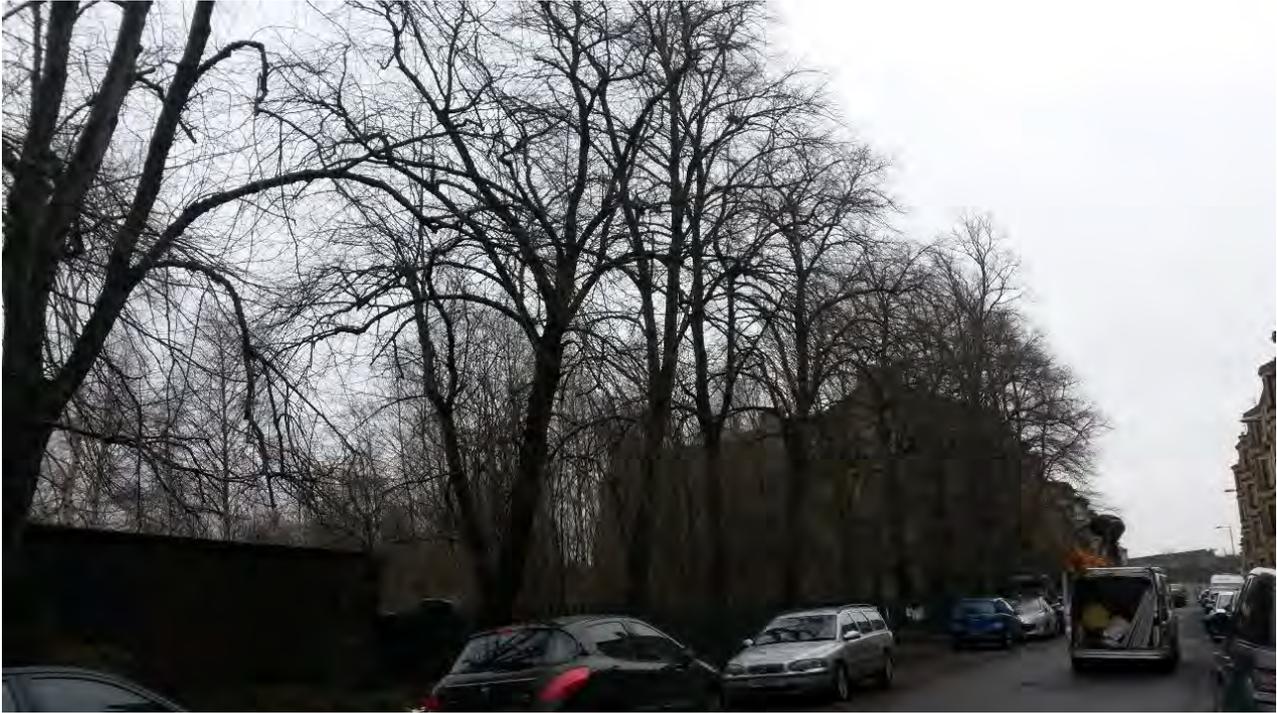
The lime trees (tree numbers 3982 – 4000) along the southern boundary are a significant feature of the site and Clouston Street. The amenity value of the trees and their contribution to the character of the conservation area has been recognised by the serving of a Tree Preservation Order on 17 of the trees. The trees are generally in good condition although some deadwood is evident in the crowns of

most as would be expected of lime trees of this age. There is a cavity at 2m on the south side of the stem of tree 3987 which requires further investigation to assess the extent of the cavity and the integrity of the surrounding wood. Given the proximity of the trees to the road and pavement, complete dead wooding of several of the trees is recommended (refer to Appendix 1 for details) to avoid damage to persons or property during high winds. The lower canopies of some of the trees are beginning to encroach on the highway and it is therefore recommended that where the canopy of a tree extends over the footpath, it is raised to a height of 2.5m and where it extends over the carriageway, it is raised to a height of 5.2m to avoid damage to branches from passing high-sided vehicles. The ground conditions within the root zones of the trees are showing signs of compaction, particularly tree 3982 which has an informal path passing through its root zone extending from a hole in the fence.

Photograph 1: *Lime trees (Tilia x europaea) on the Clouston Street boundary protected by Tree Preservation Order*

The trees would all benefit from regular mulching with, for example, wood chip, pulverised bark or leaf mould combined with well-rooted animal manure, particularly in the outer root zone where the majority of the feeder roots are found. Care should be taken when applying mulch to avoid the bark of the stem and major structural roots protruding above ground as this may encourage infection from pathogens. Ivy on the trunks and excessive epicormal growth prevented detailed inspection of the lower trunks of some of the trees. Given the proximity of the trees to major targets (residential property, pavements, public road, parked cars etc.) epicormic growth and ivy should be removed from the stems and the stems kept clear to allow for regular thorough inspection. Ivy is also becoming an issue on the ground and the dense mat that is developing is smothering other plants. Effort should be made to control the ivy growth on the ground and encourage the development of a more diverse ground flora.

The established right of way passes through the root zone of tree 3999 and this has caused serious compaction within the root zone. Gentle cultivation with hand tools is recommended to aerate the soil followed by mulching and the addition of a thick layer of wood chip over the wearing surface to reduce further damage. In the long term it would be appropriate to consider installing a 'no-dig' ground protection system for the first 10m of footpath from the entrance to beyond the trees to minimise further damage (see, for example, <http://www.groundtrax.com/> or <http://www.terram.com/>).

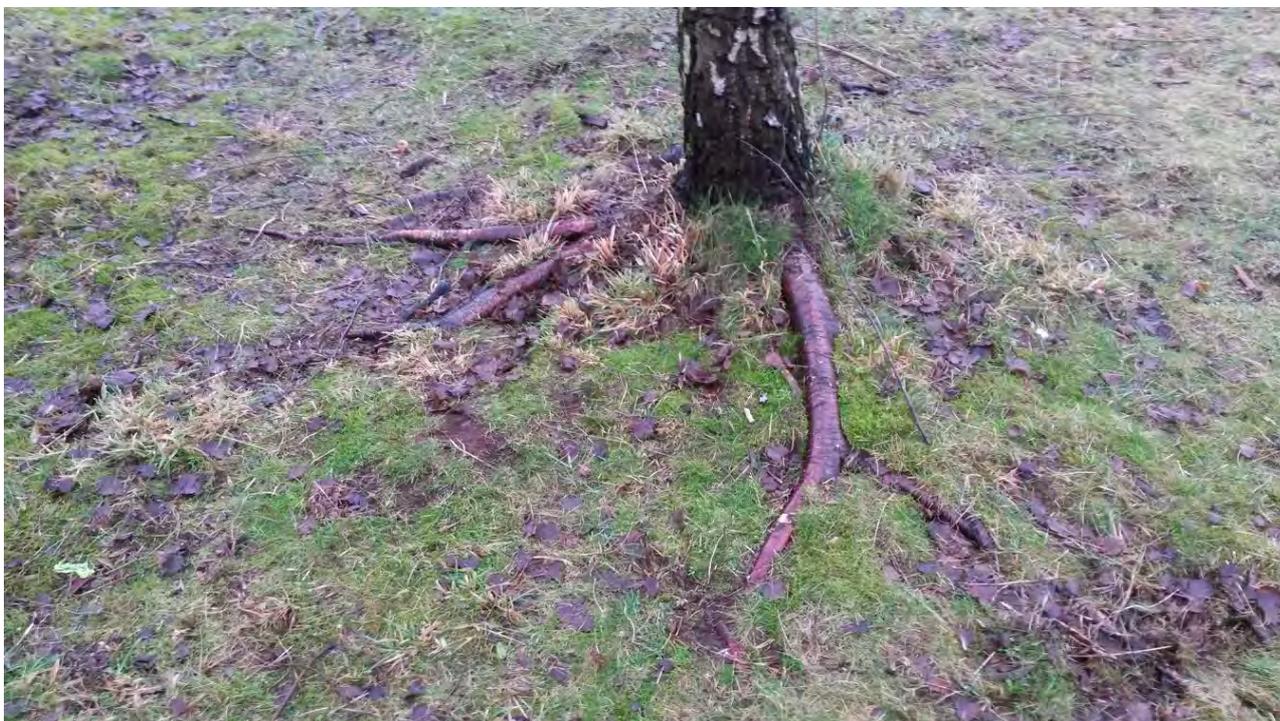
In all of the areas of woodland described below the woodland has developed on blaes and the compacted nature of the rooting medium has resulted in poor rooting conditions and exposed roots as a result. The extent of compaction and poor rooting means that the trees on the site will be more vulnerable to windthrow as they gain height and mature. There is an urgent need throughout the site to introduce management techniques to reduce compaction and improve aeration and nutrient status of the rooting medium by soil cultivation (with hand tools to minimise damage to tree roots) and frequent mulching (with well-rotted bulky organic matter) to improve nutrient levels and encourage the development of soil

Photograph 2: *Compaction and poor rooting medium has resulted in poor rooting throughout the site leaving the trees vulnerable to windthrow.*

structure. All leaf litter should be left on site (within the woodland areas) or composted and returned to the root zones of the trees.

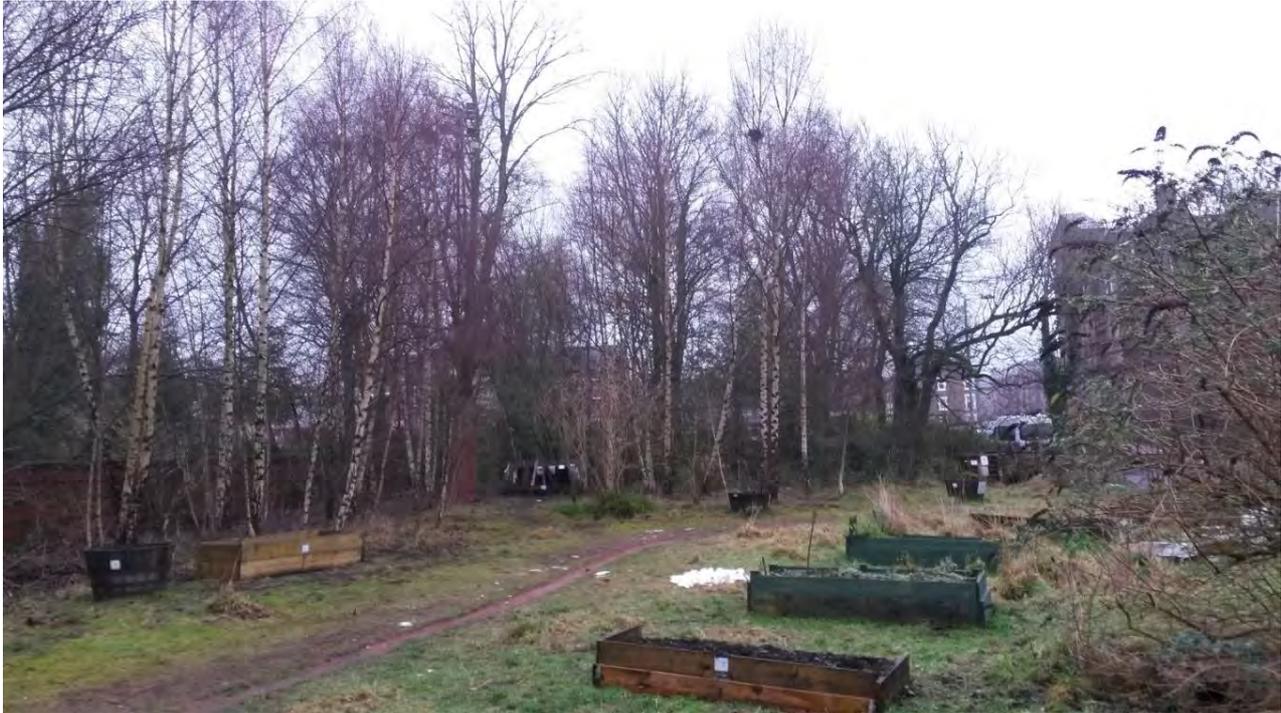
Photograph 3: W1 with community garden in the foreground

The ground vegetation in area W1 is becoming rank and dominated by aggressive weeds. The sward would benefit from some weeding, seeding and the introduction of a mowing regime (similar to that proposed below for the meadow). Some planting of (native) bluebells and snowdrops would be appropriate, particularly along the northern and western boundaries once the ivy and bramble is under control. Care should be taken to ensure that only native bluebells (*Hyacinthoides non-scripta*) are planted and not the invasive Spanish bluebell.

Young birch regeneration should be thinned in favour of single, straight stems located in more open parts of the site (e.g. the woodland edges) where they will not be suppressed by other trees and will have adequate space and light for development. Some understorey planting would be appropriate, particularly of hazel.

Soil improvement through gentle cultivation with hand tools (avoiding damage to any roots) followed by mulching should be undertaken annually to improve soil conditions.

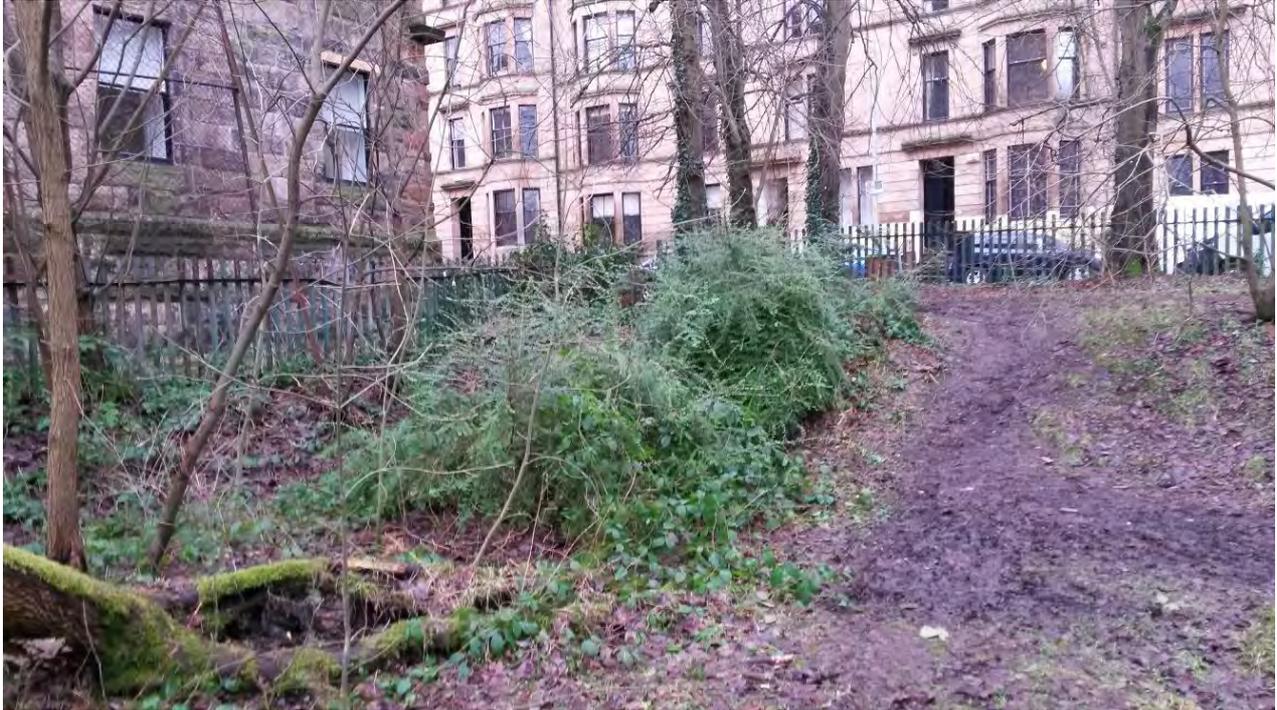
Photograph 4: *Lonicera nitida*, a garden escapee, in Compartment W2a

The garden escapees (particularly the *Lonicera nitida*) should be removed from the eastern strip of the site and supplementary planting should be carried out with hazel, holly. Several of the established birch trees within this area have developed stem sweep and should be removed once the ash saplings are more established. The aim here should be to encourage the development of low-growing woodland with occasional large trees so that the woodland does not become so dense that it causes excessive shading of the adjacent flats.

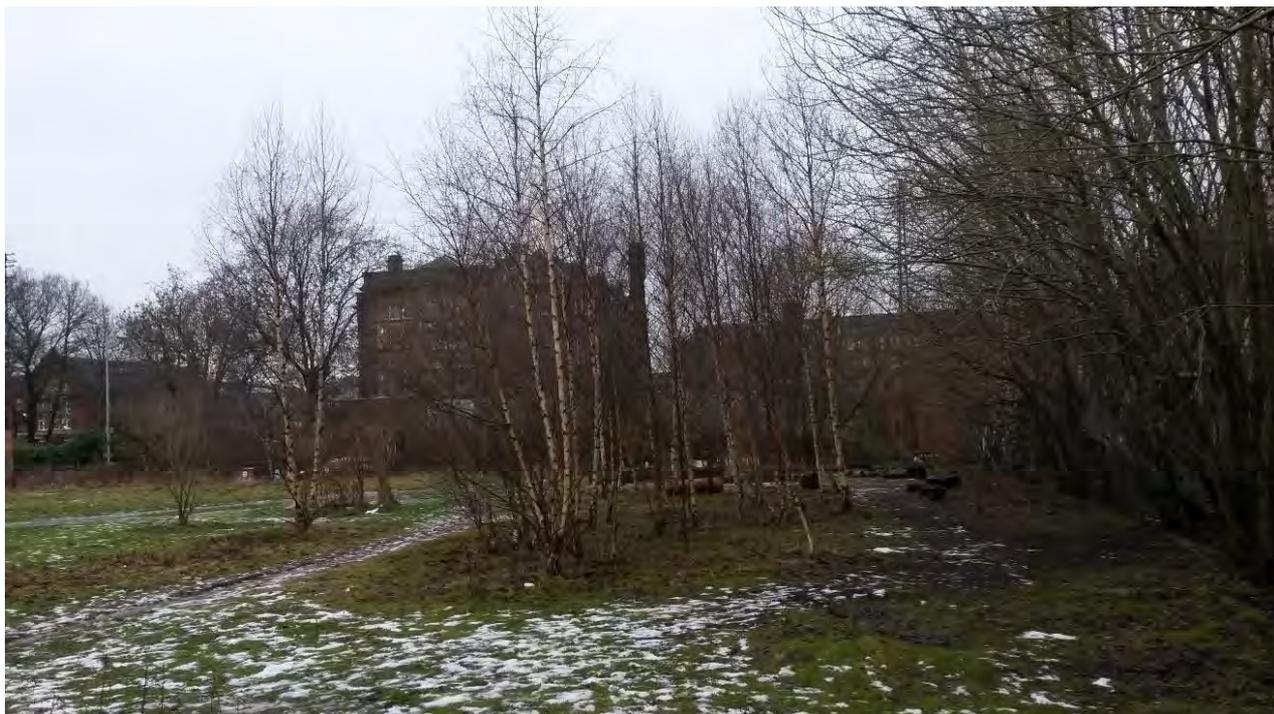
Photograph 5: Existing woodland in Compartment W3b

In the existing woodland area soil improvement through gentle cultivation with hand tools (avoiding damage to any roots) followed by mulching should be undertaken annually to improve soil conditions. Some additional planting could be undertaken to improve diversity.

The existing woodland should be thinned in favour of the better birch specimens.

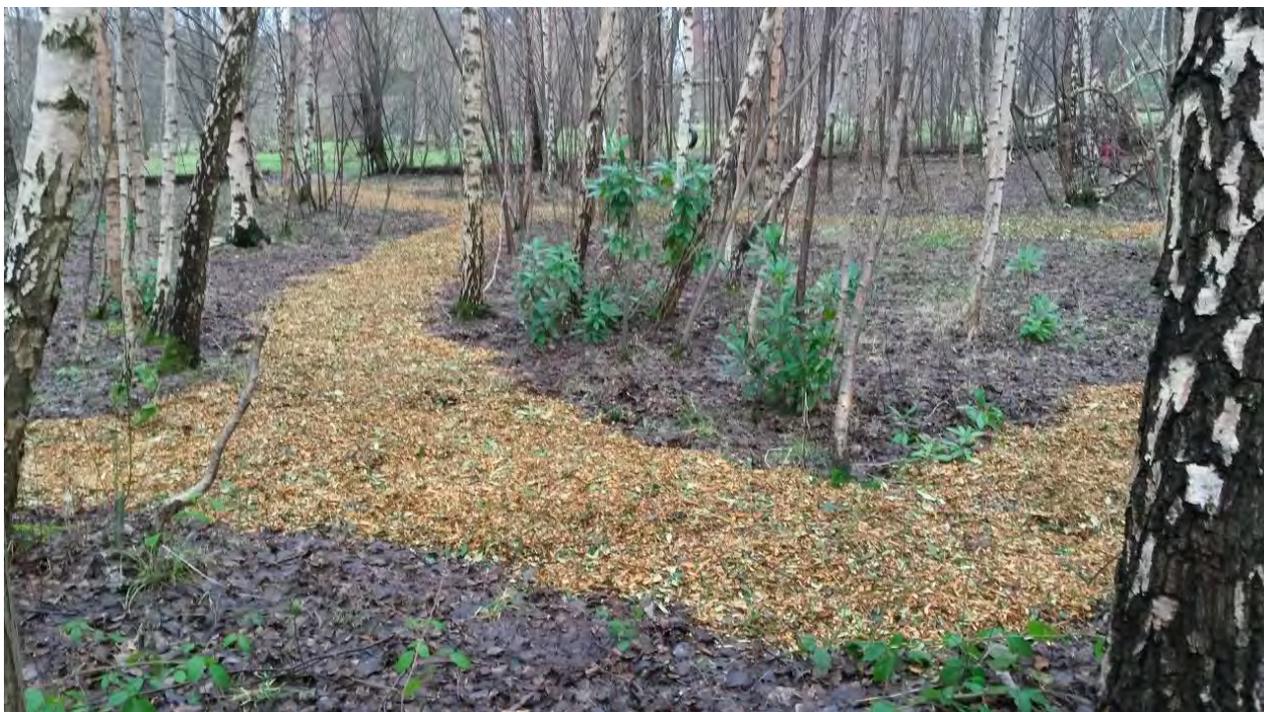
Currently there is a dense network of paths through the site, indicative of the high level of use the site receives. The resulting erosion and compaction is preventing vegetation from establishing in many areas. Work is progressing to formalise a path network through the site by delineating the preferred paths with woodchip. Ideally once the permanent path network is defined within the woodland areas, the other areas should be cultivated and planted to deter further use and to encourage development of field and understorey layers to the woodland. Once the permanent footpath network is well-defined and vegetation is established on the adjacent areas, the footpaths outwith the woodland areas could be scrapped back to the underlying blaes which is hardwearing and compact and with regular maintenance to remove leaf mould, fill holes etc. will provide an appropriate permanent wearing surface. Within the woodland areas on-going protection of the tree root systems will be required to minimise damage. Installation of 'no-dig' ground protection

Photograph 6: *Work is progressing to delineate the path network through the site using woodchip*

systems for heavily used footpaths and events areas could be considered or alternatively, on-going regular application of woodchip.

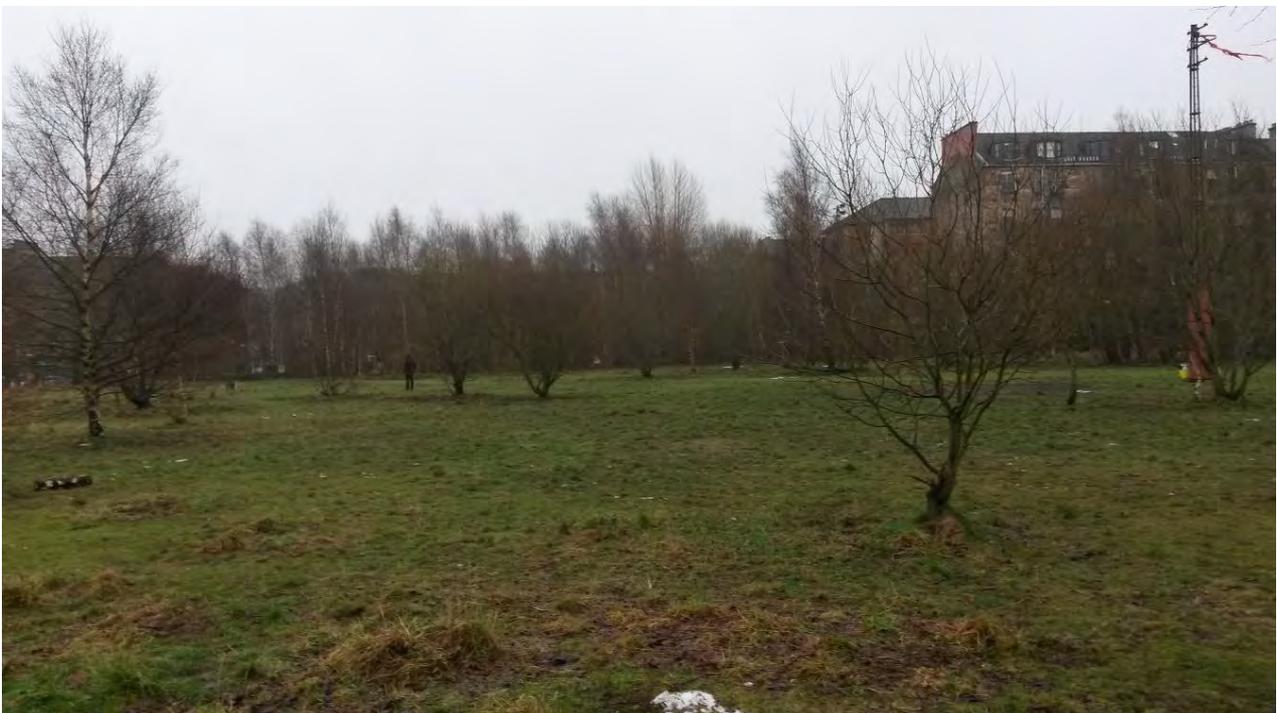
The meadow area is an important community resource that is well-used for informal recreation. As a result, it experiences a high level of trampling. The Committee's aspiration is to develop the area into a wildflower meadow but it is likely that continued heavy use of the area is likely to limit the success of this. It is therefore recommended that the central area is maintained as an area for intensive use while the peripheries and western site boundary are managed as wildflower meadows. Successful establishment of wildflowers requires low fertility, particularly for the establishment of calcareous grassland. Blaes is generally quite alkaline suggesting that the site would be suited to the development of a calcareous grassland.

Photograph 7: *Meadow area with willow natural regeneration*

However, it would be appropriate to undertake soil testing to determine the pH and nutrient status of the soil prior to progressing work on site. A lower pH may dictate that it would be more appropriate to develop neutral grassland using a general use seed mix. Soil testing will also determine whether the growing medium is nutrient deficient and inform the management of the site in terms of use of soil ameliorants (i.e. fertilisers). Following the selection of areas to be developed as wildflower meadow, the areas should be rotovated to remove existing vegetation) or dug over into the growing medium. Existing trees (particularly those tagged 5019 – 5023) should be removed from the open areas to aid future management of the site, although a few of the better birch specimens could be retained as feature trees if it was considered to be appropriate. Following weed removal, the surface of the ground should be broken up with a rake into a fine tilth during dry, calm weather to avoid soil erosion. A seed mix suited to the site (see Appendix 5 for suggested species mixes) with a ratio mix of grass seed: wildflower seed of 4:1 at a rate of 2-5 should then be sown at a rate of 2-5g/m². Local (Scottish) suppliers (e.g. <http://www.scotiaseeds.co.uk/>) should be able to provide seed of Scottish provenance. If sowing by hand, the seed should be mixed with damp sand or

In order to maintain and develop biodiversity interest it will be necessary to mow the meadow areas. In the first year the emerging meadow should be cut to maintain the sward at height of 10-15cm (but not less than 5cm). Cuttings should be removed from the site to retain low fertility. In the second and subsequent years the meadow will require cutting at least once, preferably in late summer/early autumn once the plants have flowered and set seed. An occasional spring cutting will help to keep pernicious weeds (e.g. nettle, docks, dandelions etc.) and developing scrub in check, although hand pulling or spot spraying with an approved herbicide may be more suitable management for small meadow areas.

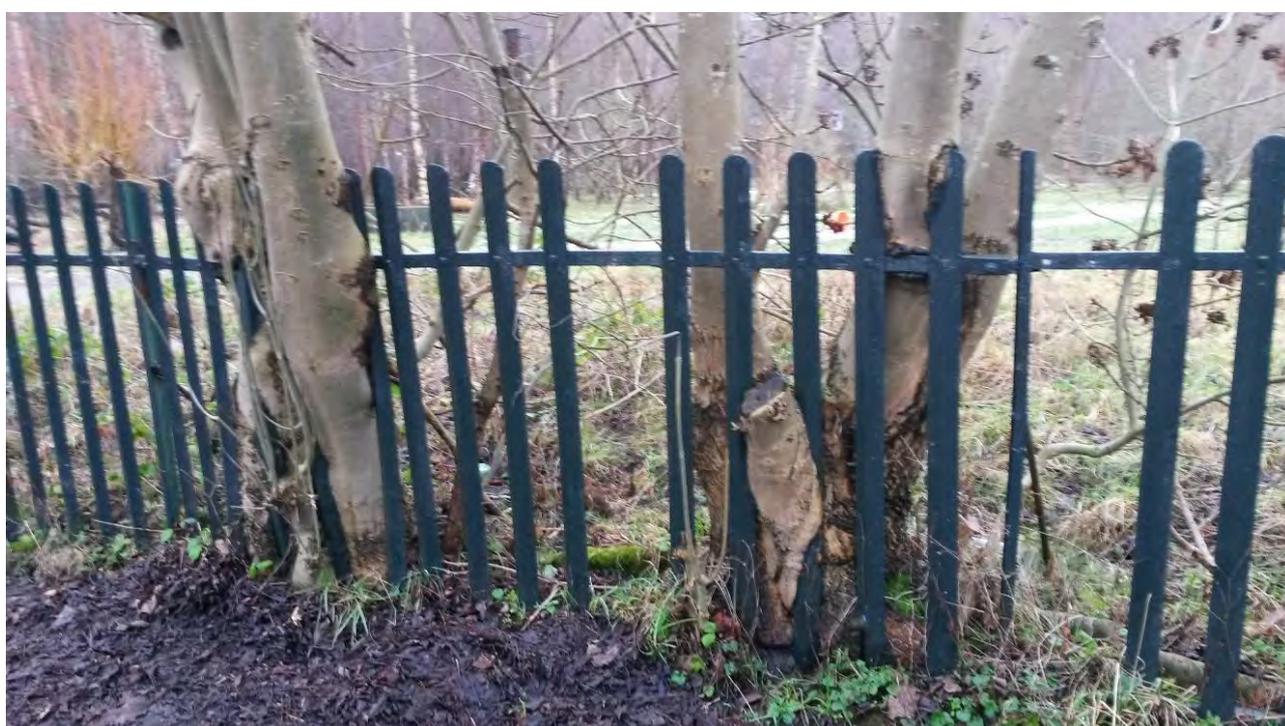
The metal palisade fence which extends along much of the site boundary is a feature of the area, particularly the Clouston Street and Kelbourne Street boundaries. Most of the fence is still present on site but is being damaged in places by tree regeneration. The trees growing through the fence are generally poor specimens that are damaged to a point that they will have reduced life expectancies. The roots of some of the trees on Kelbourne Street are also damaging the pavement.

Photograph 8: *Trees damaging the boundary fence on Kelbourne Street*

Ideally all of the boundary trees that are growing through the fence should be removed and the fence repaired. There are significant opportunities along the boundaries, particularly the Kelbourne Street boundary to establish trees set back from the boundary. Species such as rowan and whitebeam would create an attractive feature along the boundary to the west of the entrance. To the east of the entrance, bordering the woodland along Kelbourne Street and along the Sanda Street boundary it would be appropriate to establish a hedge. A suitable
