## Summary Report

285 Wallacewell Road  
Glasgow  
G21 3RP

**Beatroute Music Group**

Report Date: 30<sup>th</sup> September 2010

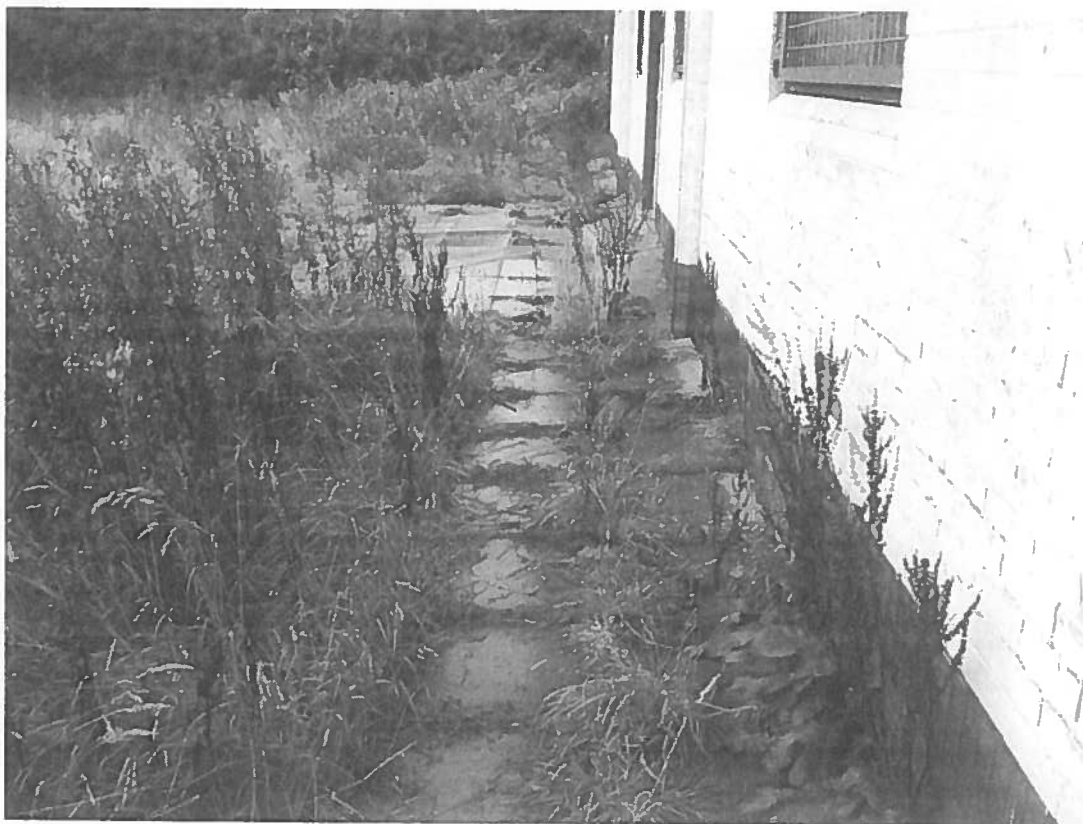
- 3.31 The pavement to the west elevation is ramped steeply at its centre to accommodate the external fire exit door. The gradient of the slabs is greater than permitted by current Building Regulations which also require a level exit plinth with an unobstructed length of 1.50m before the exit route is ramped to adjacent pavements. The paving slabs have also been positioned so that they sit proud of the exit threshold, creating a trip hazard. We would recommend that the exit paving be re-formed.

**4. PAVEMENT TO WEST ELEVATION**

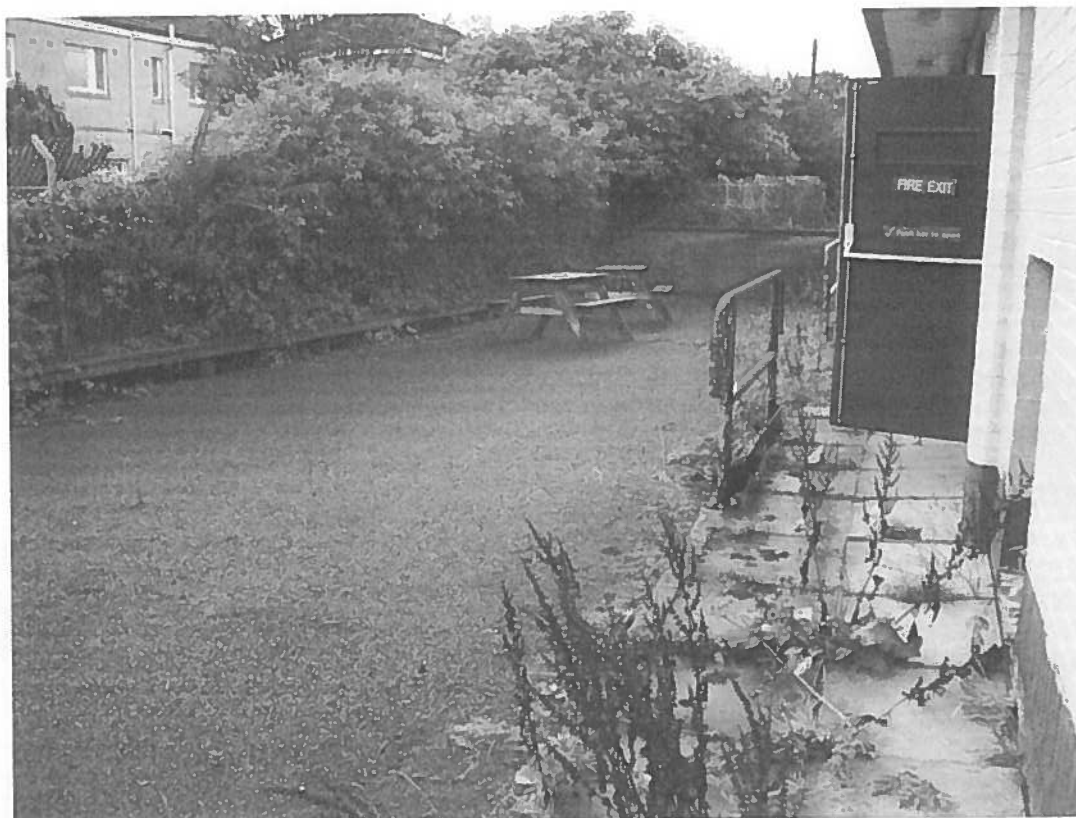
- 3.32 Bitumen macadam to the external yard to the north of the property and the entrance roadway and car park to the east side of the property is substantially sound, although locally breaking up. There is also weed growth penetrating the bitumen macadam which is likely to cause further deterioration. The weed growth requires to be removed, destroyed and localised repairs undertaken to the surface.

**5. YARD TO NORTH OF PROPERTY**

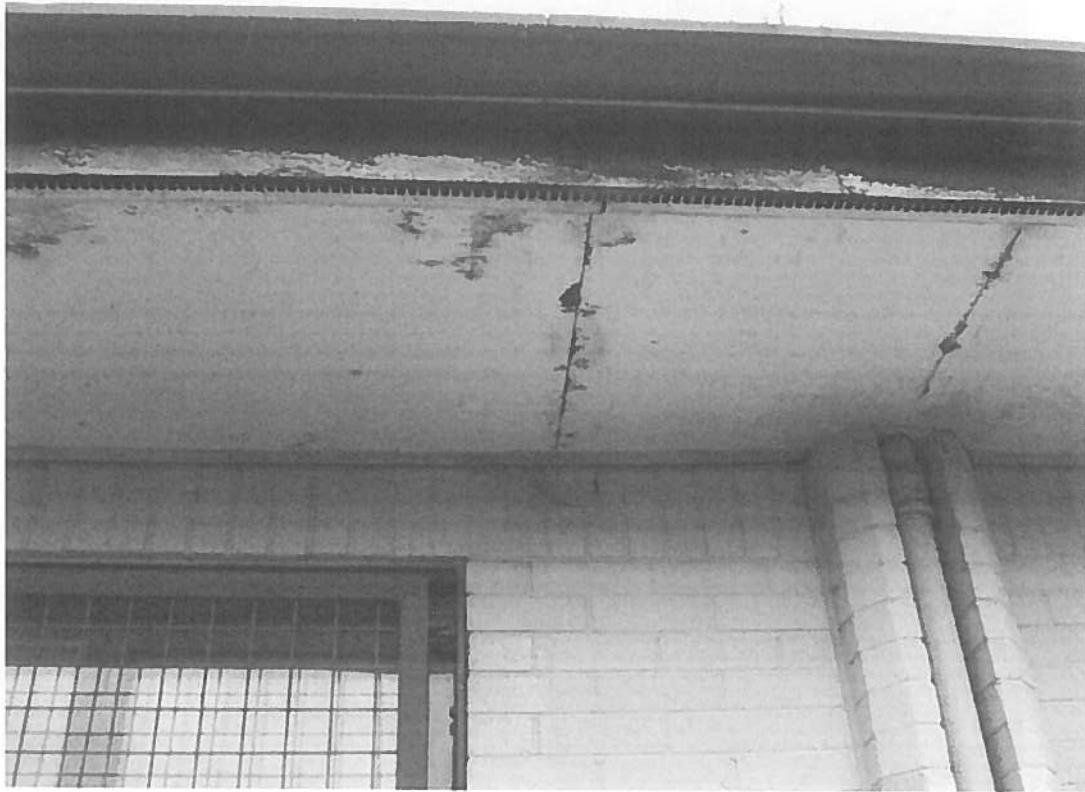
- 2.13 Perimeter eaves guttering is in poor condition, with extensive vegetation growth noted, together with a number of leaking joints. Extensive water penetration through the eaves soffit is occurring to the west side of the property, and it is probable that a short length of horizontal downpipe, concealed within the eaves detailing and connecting the gutters to the cast iron downpipes, is damaged or displaced. The outside edge of the guttering is warped in areas, which has probably arisen as a result of attempts to gain access to the roof. This has, in particular, resulted in extensive damage to the guttering either side of the roof situated over the principal entrance on the south elevation. The eaves guttering requires extensive repair, including cleaning out and re-levelling.

- 3.11 The gutters are connected to the downpipes via short lengths of shallow pitched downpipes concealed within the eaves soffit. Extensive water penetration was noted through the soffit to the west side of the roof, suggesting that the concealed length of downpipe in this location is broken or disjointed. The soffit requires opening up and the downpipe repaired as necessary.

**7. WATER DAMAGE TO SOFFIT BOARDS**

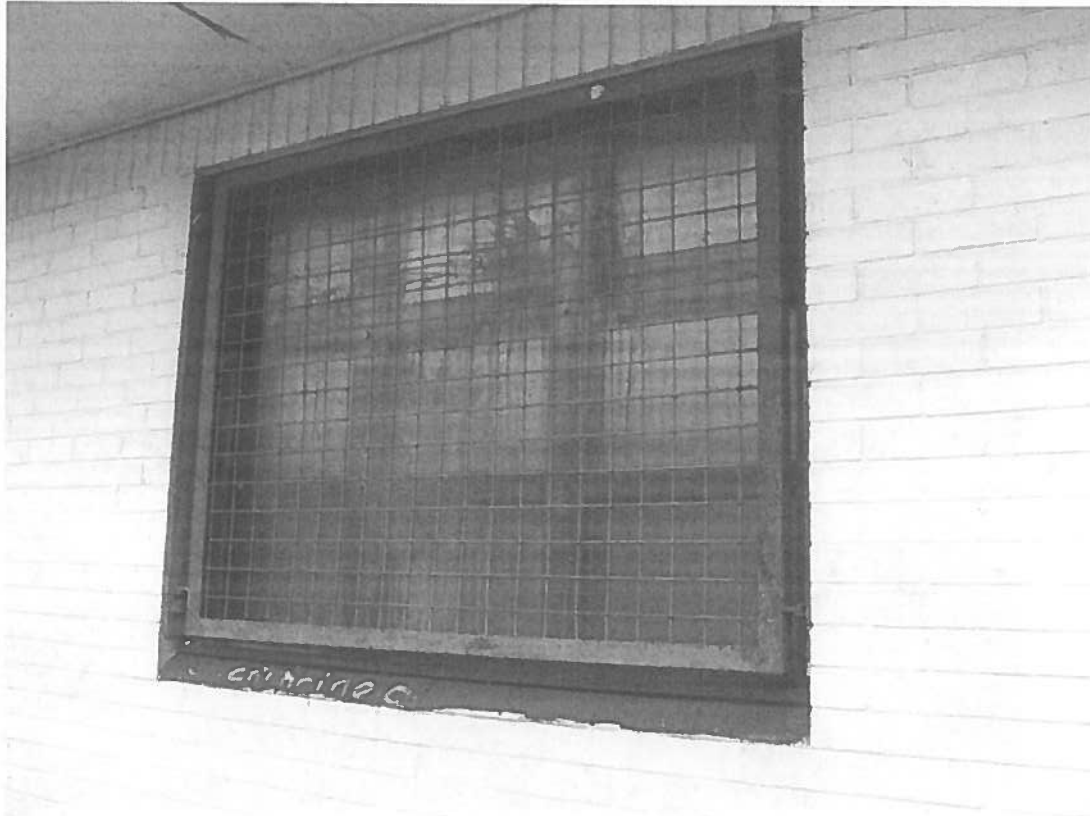
- 2.19 Exterior windows and doors are in fair to poor decorative order generally, with the windows towards the front end of the building particularly soiled. Perimeter mastic seals to the perimeter windows are also locally damaged, and the protective grilles are in poor decorative order with an extensively flaking paint finish. Perimeter seals, where visible, are cracked and debonding. Doors have been defaced by graffiti. All are in need of cleaning down and redecoration, with the replacement of damaged perimeter seals.

**8. TYPICAL WINDOW**

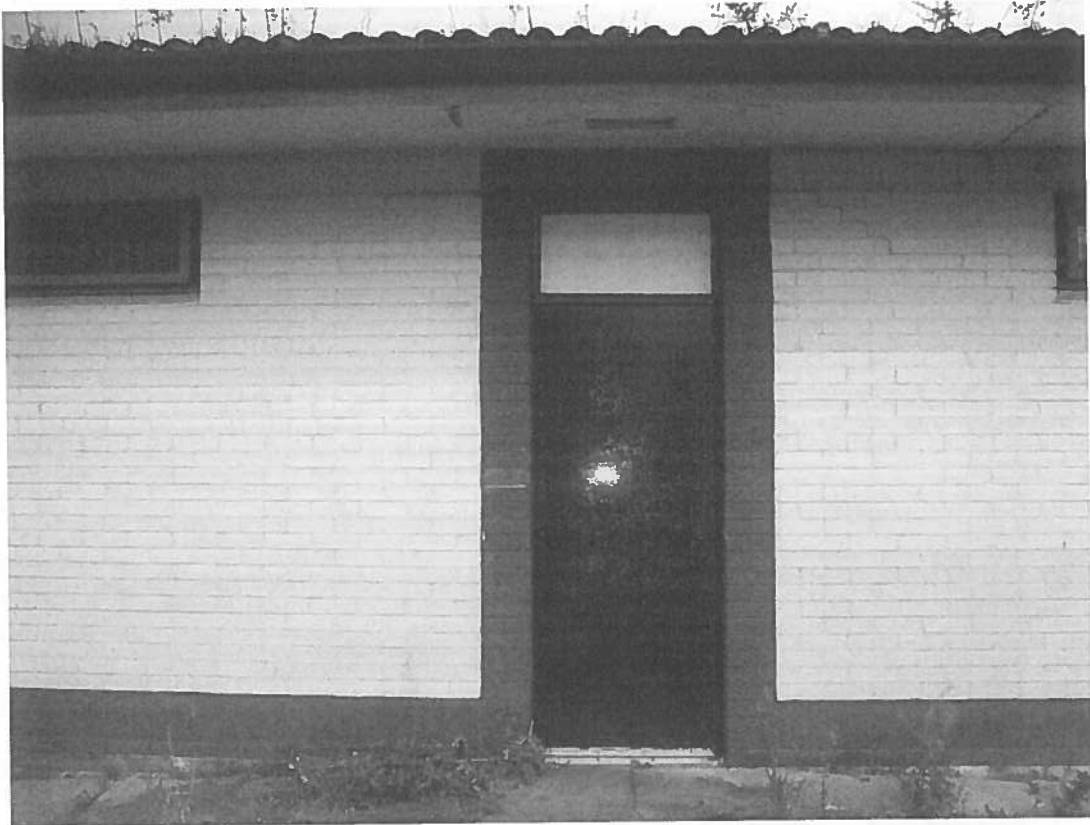
- 2.17 Stepped cracking is situated to the high level brickwork either side of the central fire exit door to the east elevation. This cracking appears to have arisen as a result of additional loading added to the roof structure from scaffolding and 6 No. punch bags within the Games Hall. The brickwork will require repointing prior to redecoration and we would recommend that consideration be given to removing the scaffolding and punch bags supported from the roof structure to avoid further damage.

- 3.19 Mortar pointing is substantially sound, although locally eroded at low level, particularly to the south elevation. Step cracking is present through the brickwork at high level, located either side of the fire exit door to the east elevation. The cracking appears to be the result of additional weight added to the roof structure within the Games Hall, where scaffolding spanning the roof structure has been used to support 6 No. punch bags. The weight of these punch bags is considerable, and consideration should be given to their removal to avoid further damage. The brickwork externally will require repointing.

- 3.42 The roof structure within the Games Hall has been augmented with the addition of scaffolding to support 6 No. punch bags. The weight from the scaffolding and the punch bags will be significant, and this appears to have contributed to the stepped cracking noted either side of the fire exit door to the east elevation. The punch bags should be removed to avoid further damage.

**9. CRACKING TO BRICKWORK TO EAST ELEVATION OF GAMES HALL**

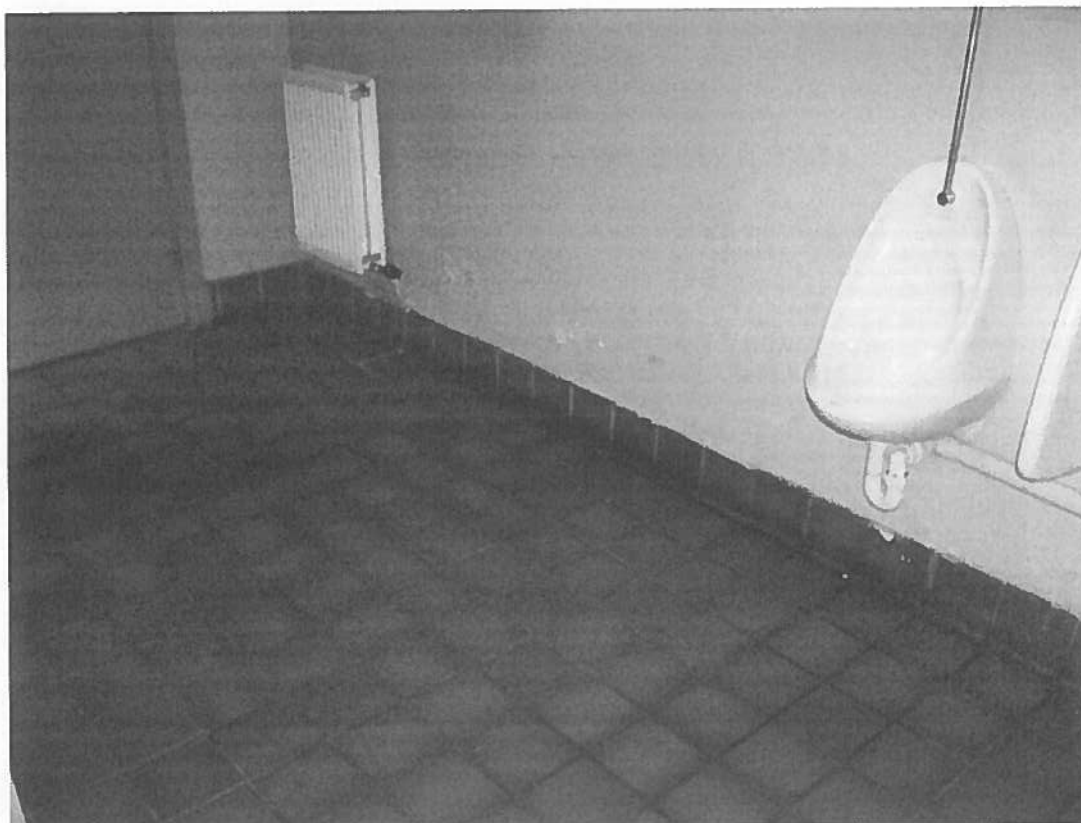
- 2.21 Localised dampness was noted at the base of the internal walls within the toilet facilities and to the north end of the Games Hall. This has resulted in deterioration of the plaster and paint finish to the walls, and whilst not of significant nature, the situation should be recorded prior to entering into a leasehold interest in the property.

- 3.44 Localised dampness was noted at low level to the walls within the toilet accommodation, particularly the female toilet, in the northeast corner of the property and to the north wall of the Games Hall. This has resulted in localised deterioration of the plaster and paint finish. The source of the moisture is not clear and it may be the result of a localised breach in a damp proof membrane. If it is of concern, localised repairs would be recommended which, if necessary, may require the insertion of a chemical damp proof course prior to the repair of the plaster and decorative finishes.

**13. DAMP AFFECTED PLASTER TO MALE TOILET**

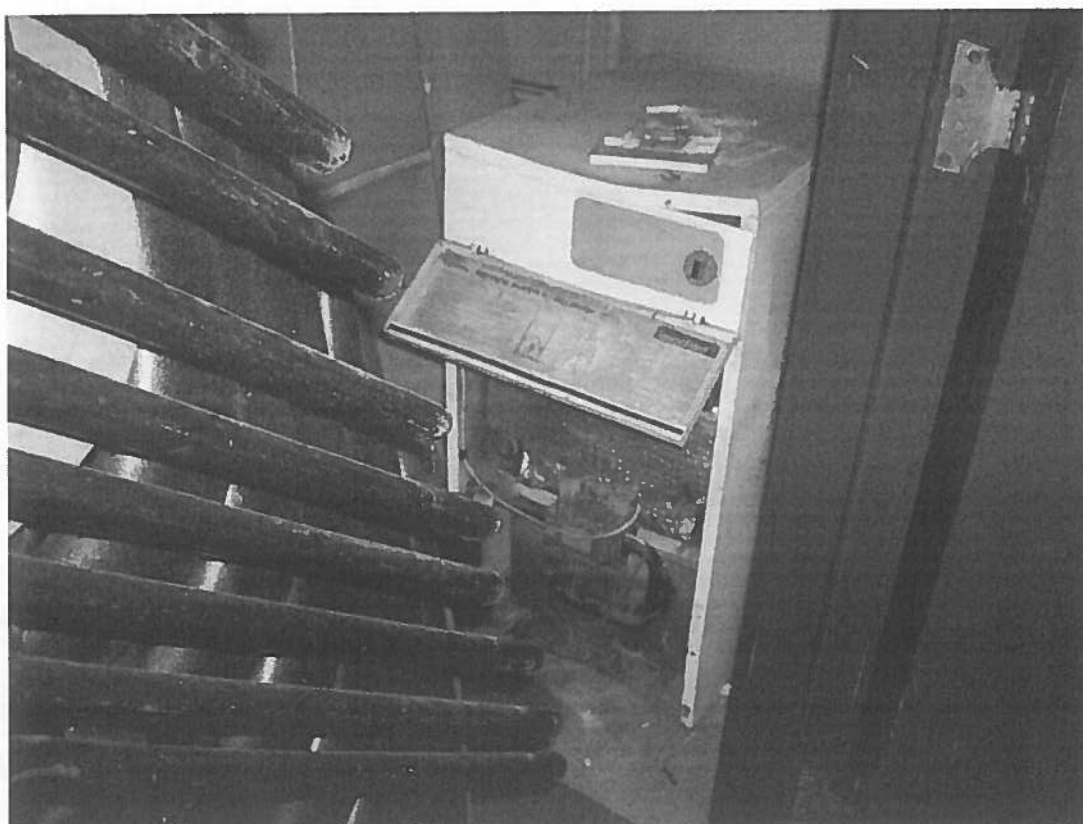
- 2.25 The gas fired boiler installation was producing a burning smell at the time of our inspection. The boiler is old and we would strongly recommend that it is inspected, repaired and certified as safe by a competent qualified, Corgi registered, or equivalent engineer prior to further use.

- 4.07 The boiler is an Ideal Standard "Mexico Super II" and appears relatively old. At the time of our inspection, a smell of burning was noted, and following discussion with the Tenant we understand that the boiler had been switched on for the first time in a period of approximately 6 months earlier that morning. During the course of our inspection the boiler was inspected and the gas supply switched off by representatives of City Property LLP. The boiler appears to be approaching the end of its effective life and will require inspection and certification by a Corgi registered engineer or equal and approved. It is possible that the boiler will require replacement, if not now, then within the next few years.

**14. BOILER**

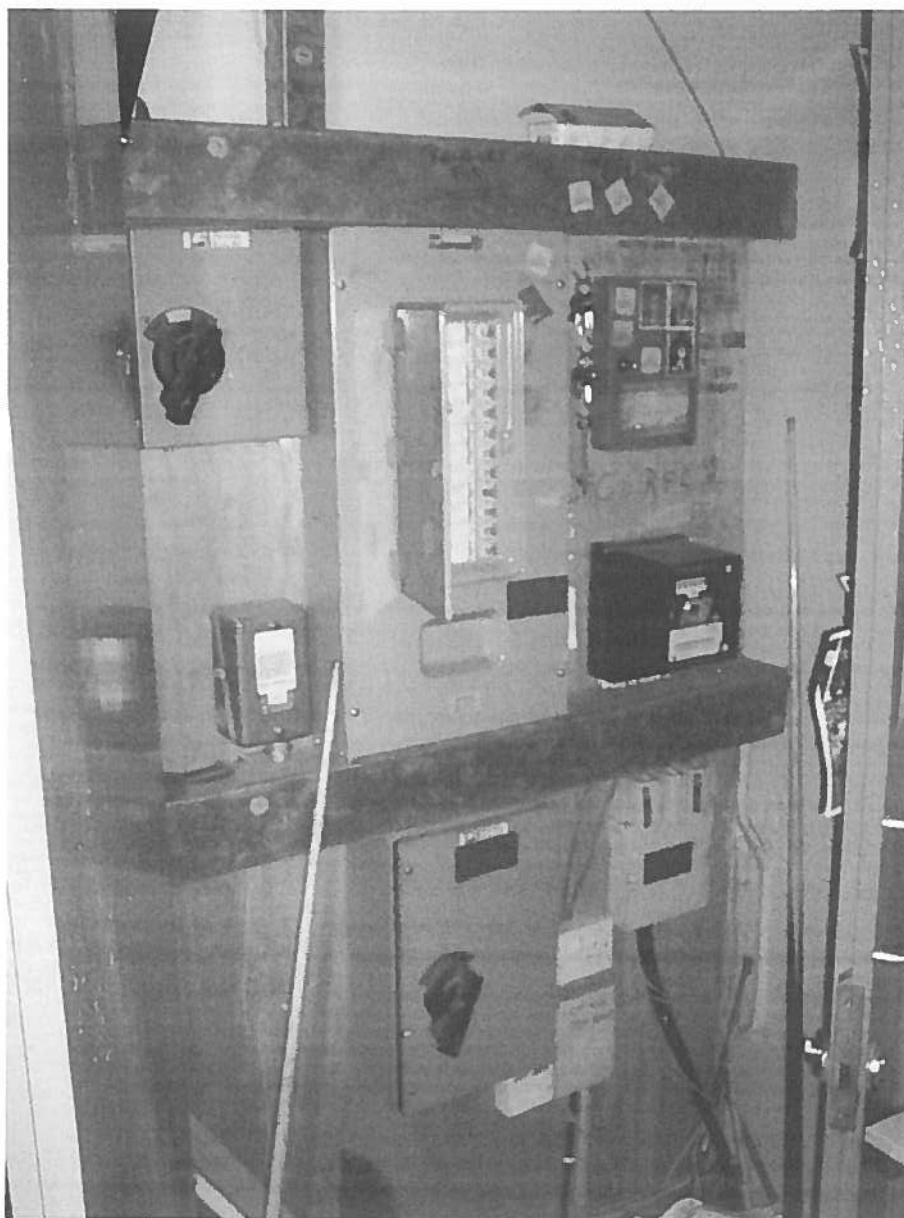
- 4.01 The property is served by a 3-phase electrical installation, with the incoming main, meter and switch gear situated within a cupboard located within the "Caretaker's" office to the east of the principal entrance to the property. The installation incorporates a modern 24No. way distribution board. Small power throughout the property is primarily by recessed single and twin socket outlets with plastic cover plates, although isolated aluminium socket plates were noted. Switch plates are in plastic and lighting is a combination of fluorescent and tungsten fittings, although predominantly the former. Flood lighting is also present at high level within the Main Hall and Games Hall.

- 4.02 The electrical installation appears reasonably modern and in fair condition, although should be inspected and tested by a competent qualified electrician. Minor gaps were noted between isolated socket plates within the "Caretaker's" office and to the north wall of the Games Hall, and these should be sealed to prevent the insertion of foreign objects. A switch plate serving the lighting within the cleaner's cupboard is broken and inoperable, and a recessed spotlight is missing from the soffit of the entrance lobby to the male toilet.

**15. ELECTRICAL SWITCH GEAR AND METER**
