Job No: G8591  
Client: Trinity Residents' Association

Trinity Tower  
35 Lynedoch Street  
Glasgow G3 6AA

## Verification of Collapse Risk February 2022

Title: Trinity House Tower, 35 Lynedoch Street, Glasgow G3 6AA

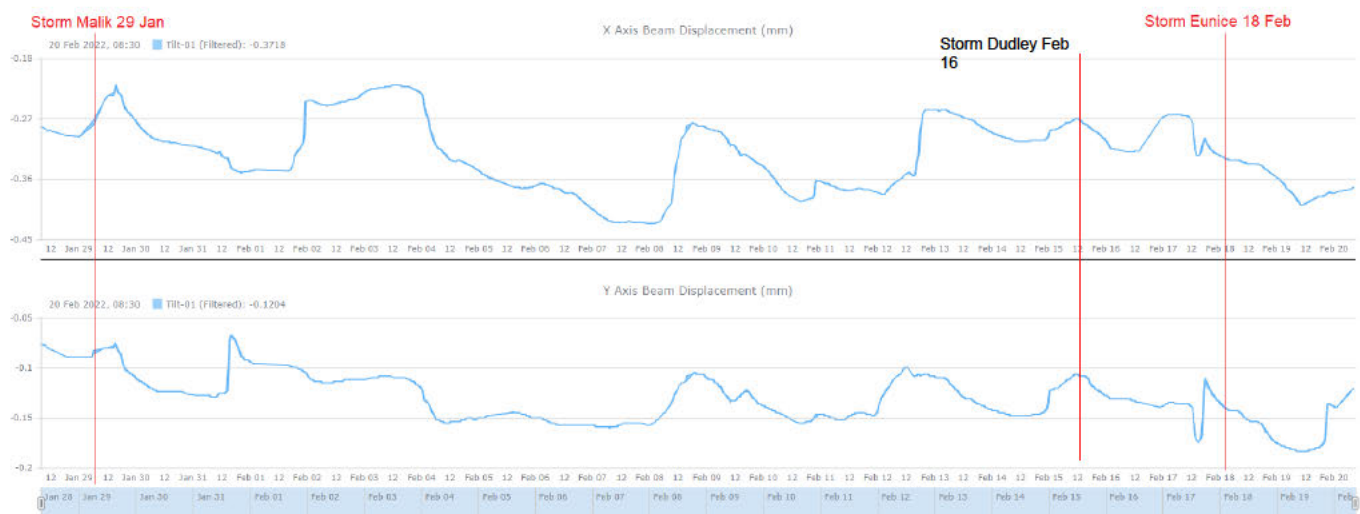
Figure 2: Extract Tilt Monitor Trace

The tilt monitors have been measuring storm events since June 2020 and the towers oscillations have been recorded during several storm conditions over this period. Each 'trace' shows a consistent oscillation between flexing and recovery, measuring only a few millimetres.

During storm Malik we experienced alarms sounding from our tilt monitors, showing a sharp rise in tilt after which the sensors went offline. Our engineers had to assume the worst in that there was a possible unnatural movement in the tower (significant event) and therefore immediately raised the issue with the contractor, project team, and client group. We immediately initiated 'eyes on protocols.' Once we had ascertained it was safe to enter the tower all monitors were checked and reset, all tell-tales and crack propagation tags were measured and checked, together with a full reinspection of the building to ascertain if there had been any fresh damage caused. All results returned negative by the 2<sup>nd</sup> of February, and we concluded the storm had not caused any damage to the buildings overall structural stability and that the risk of collapse was very low. It can be seen for the trace above that the tower experienced a catalogue of wind gusts between the recent storms. The tower is very exposed on the brow of a small escarpment making high wind gusts more frequent than normal conditions. However, the traces during this period are no different from those measured in past previous high winds, with all of them showing elastic oscillations with no evolving trends.

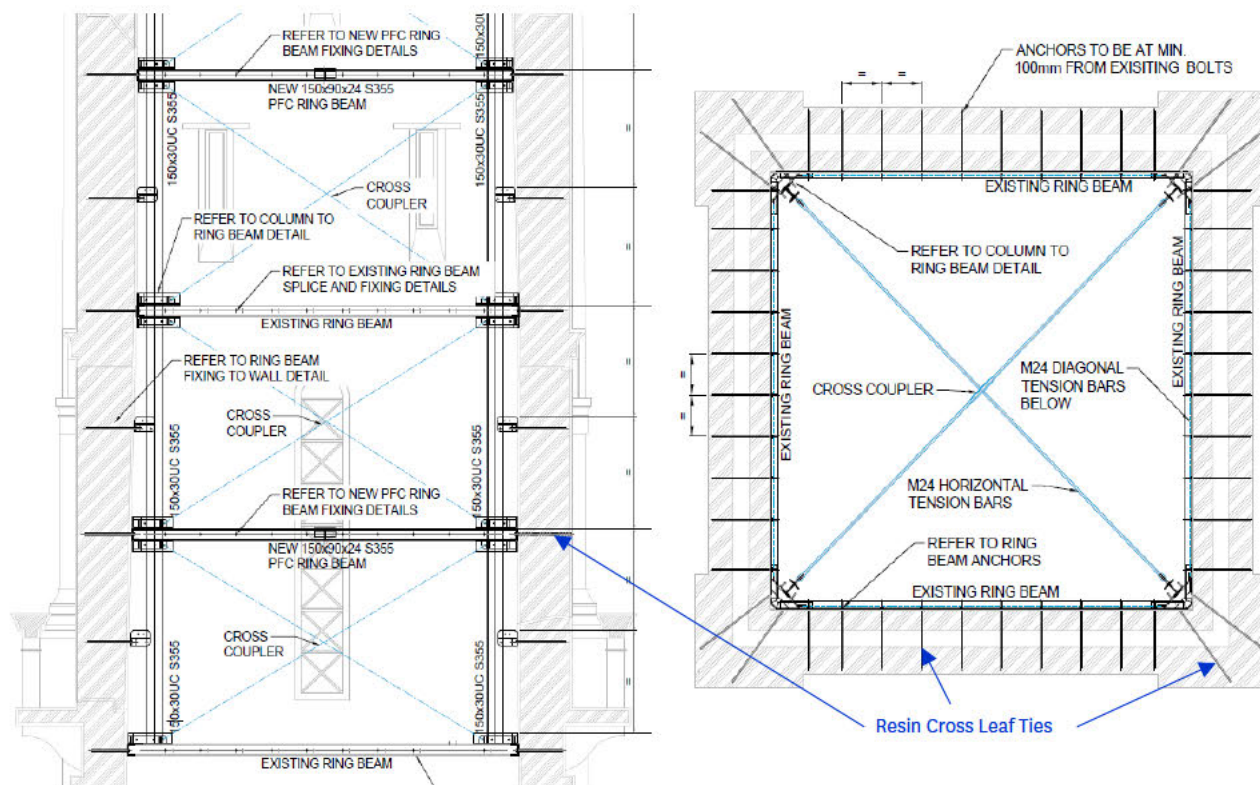
Figure 3: Extract from stent design information

All the above is achieved by a rectangular braced tube structure inserted internally in the tower, analogies to a surgical stent, to create a rigid frame to which the inner and outer leaf of the tower walls can be tied back to. It will have the added benefit of reducing the risk of overall collapse from very low to negligible.

The goal of the proposed repair works commenced in January 2022 was to reduce the vulnerability (see 4.3a) of the towers structure to 'low' by installing the following structural enhancements.

- reinstate the towers 'box rigidity',
- tie the inner and outer walls together from the inside.
- reduce the slenderness of the vertically fractured segments of the towers structural form.
- Improve / stiffen the wall panels directly above the bulged south wall to increase safety when inserting the temporary needle supports before renewing the wall.
- Enable external repairs to be carried out unhindered by exoskeletal bracing.
