# Glasgow South City Way

Protected junctions and their impact on user comfort and safety

28 April 2022

Document details	
<b>Reference ID:</b>	SUSR2094
<b>Version:</b>	V1.0
<b>Client:</b>	Glasgow City Council
<b>Circulation Status:</b>	External – restricted to the client
<b>Issue Date:</b>	28/04/2022
<b>Author(s):</b>	Ben Farrington
<b>Reviewed by:</b>	Jack Clarkson
<b>Signed off by:</b>	Nigel Donnell
<b>Accepted by:</b>	
<b>Contact:</b>	ben.farrington@sustrans.org.uk

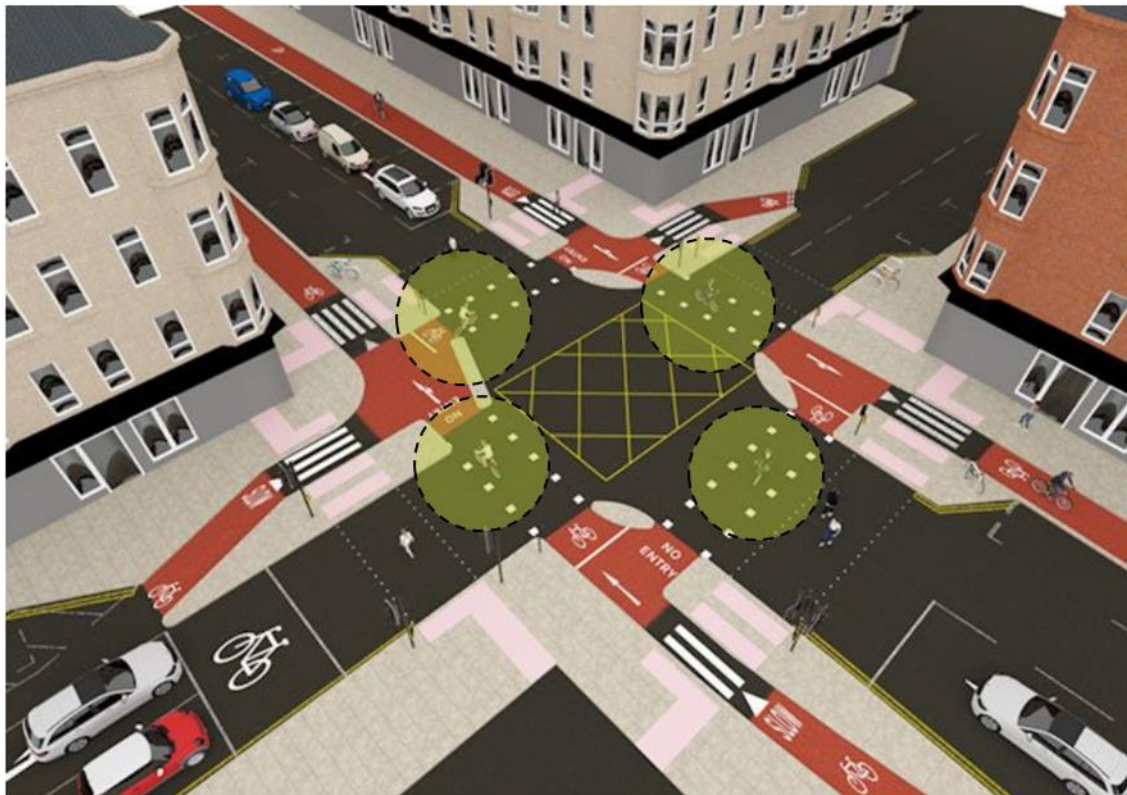
**Figure 1: Cyclists using the protected cycleway to turn right at Allison Street junction**

Cyclists travelling along the SCW follow a segregated cycleway. At the protected junction cyclists remain on the segregated cycleway separated from other users including when turning left and turning right at the junction. The aim is to make the junctions safer for all road users, and particularly for people on cycles. Figure 1 shows a design for the protected junctions on Victoria Road. At both junctions the road crossing Victoria Road is 1-way to cars and cycles.

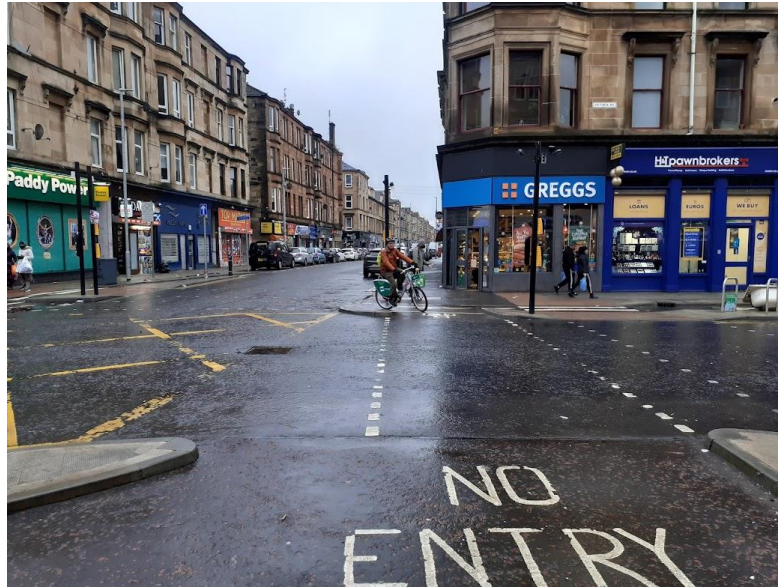
**Figure 2: Cyclist using the protected cycleway to turn right at Allison Street junction**

Figure 2 and Figure 3 show pictures taken during a site visit to the SCW in December 2021. They show a cyclist using the segregated cycle lane to turn right and pedestrians & cyclists waiting to cross at the junction with one pedestrian jaywalking.

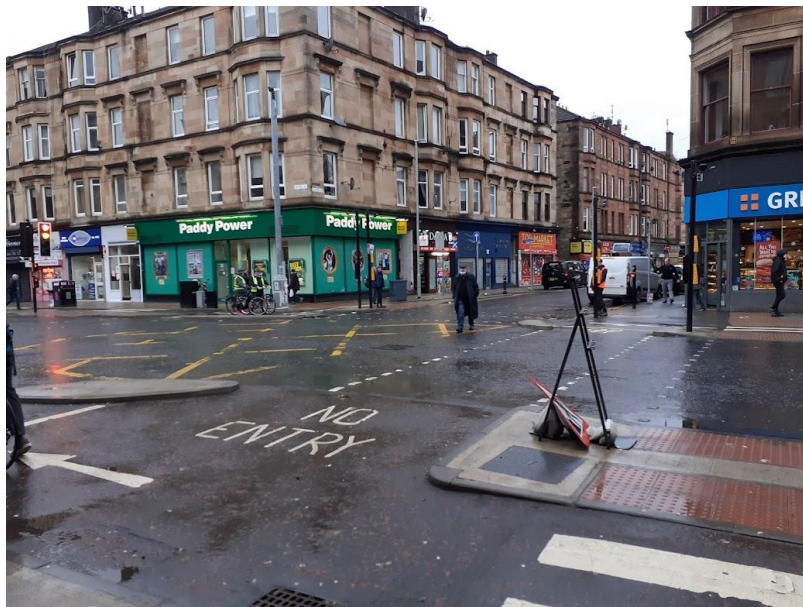
**Figure 3: Pedestrians using the protected junction at Allison Street junction showing compliance (in background) and jaywalking (in foreground)**
