Glasgow City Council – Neighbourhoods and Sustainability

Cycle Lane Soft Segregation Trial Report

FEBRUARY 2020

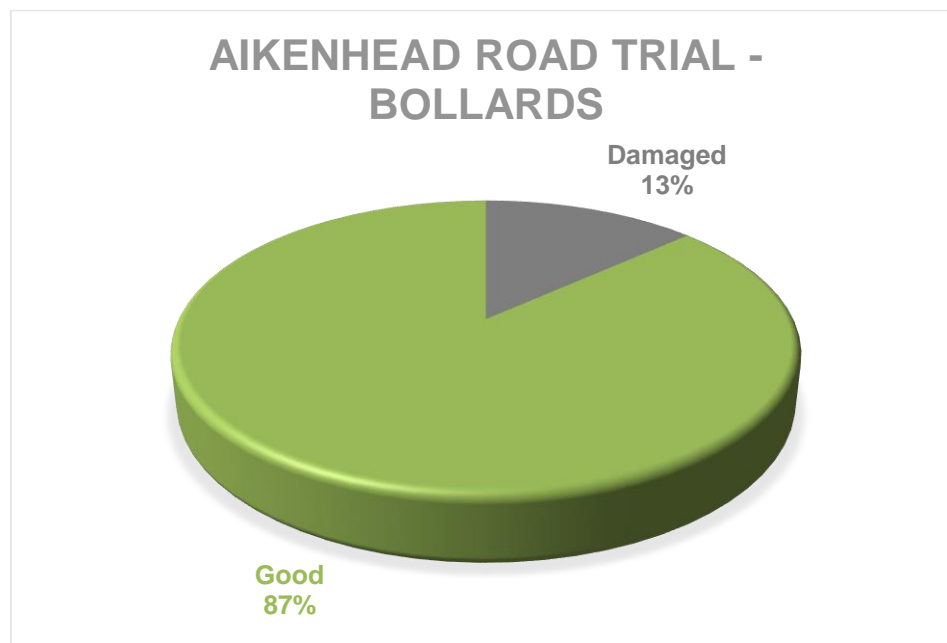
Figure 7: survey results for bollards along Aikenhead Road.

A total of 15 units were observed. This number coincides with the number of units originally installed. 2 bollards were damaged (refer to figure 8 & 9) and 13 were found to be in good conditions (refer to figure 10) as shown in the graph below, (refer to figure 7 and table 2).

Observations	Damaged	Slightly Damaged	Good
15	2	0	13

For further installation of Bollards it is recommended for the products to be resin in rather than bolted.

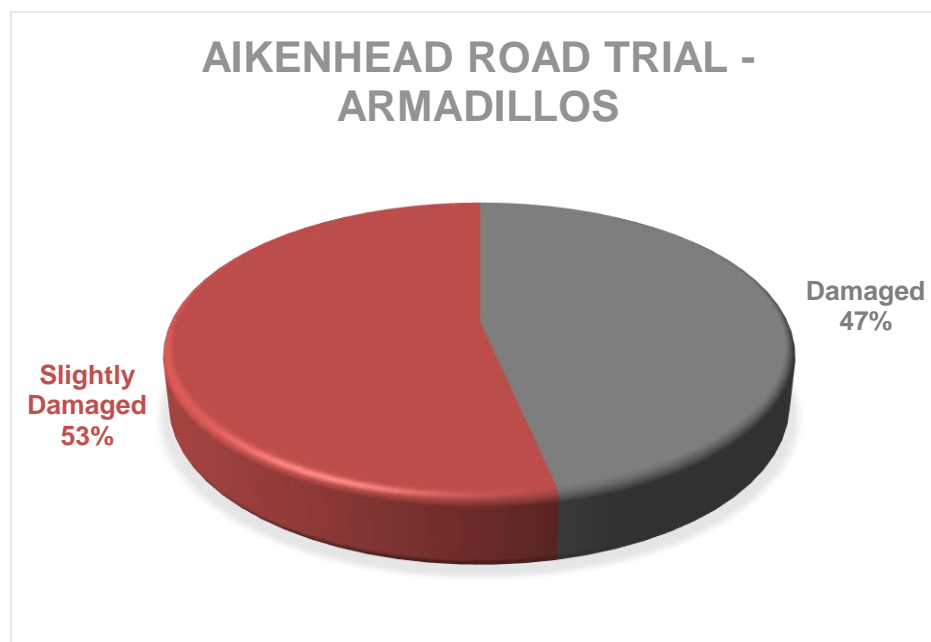
Figure 11: survey results of Armadillos on Aikenhead Road.

A total of 30 units were observed. This number coincides with the number of units installed. All Armadillos are intact but 4 Armadillos (refer to figures 12 & 13), showed signs of damage mainly to the top/surface area. 16 units were found to be slightly damaged (refer to figure 14), showing signs of discolouration.

Observations	Damaged	Slightly Damaged	Good
30	14	16	0

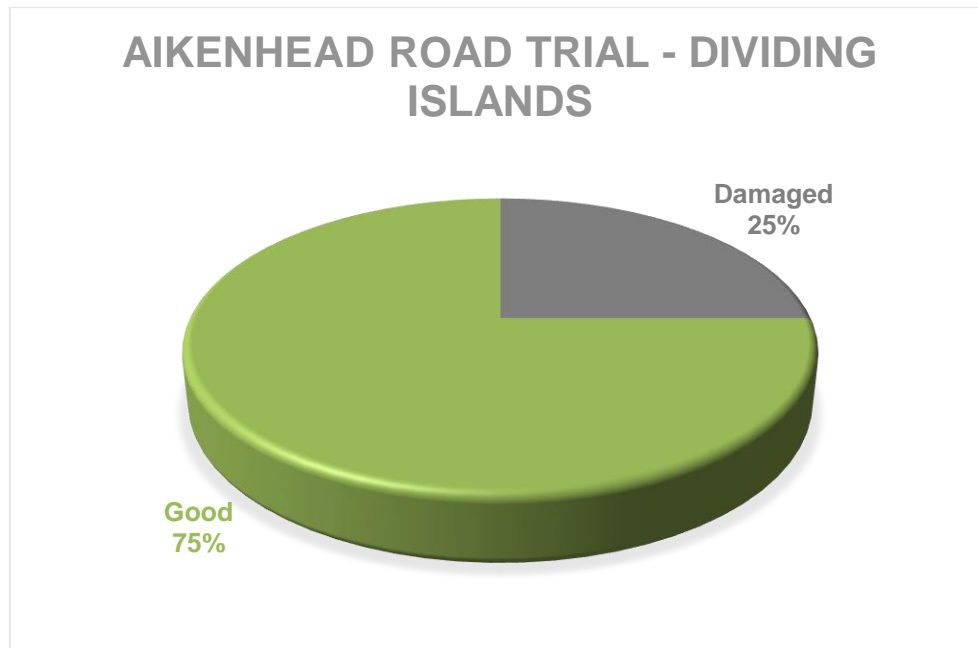
Figure 15: survey results for dividing islands on Aikenhead Road.

A total of 4 units were observed. This number coincides with the number of units originally installed. 3 out of 4 dividing islands are intact and 1 island (refer to figure 16) was missing. 3 units were found to be in good conditions (refer to figure 17).

Observations	Damaged	Slightly Damaged	Good
4	1	0	3

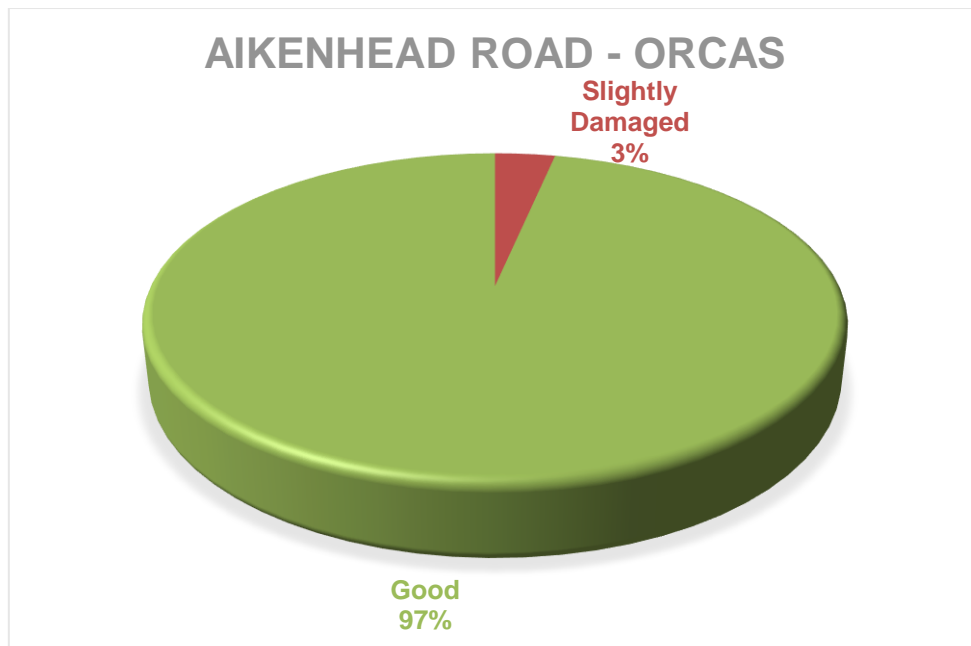
Figure18: survey results of Orcas on Aikenhead Road.

A total of 30 units were observed. This number coincides with the number of units originally installed. All Orcas are intact. One Orca was found to be showing signs of minor damage (refer to figure 19) and all remaining 29 units were found to be in good conditions (refer to figure 20).

Observations	Damaged	Slightly Damaged	Good
30	0	1	29

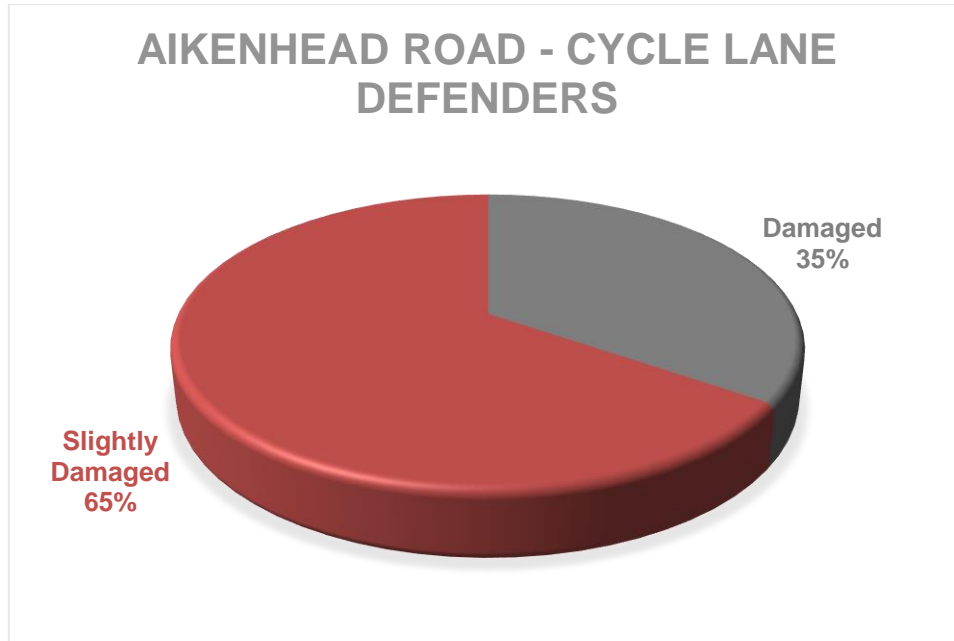
Figure 7: survey results for Cycle Lane Defenders on Aikenhead Road.

A total of 26 units were observed. This number coincides with the number of units originally installed. All Defenders are intact, however the reflective strip on all 26 units has or is in the process of peeling off, this seems to be happening mainly on the side of the cycle lane. All weepers appeared to be blocked with debris/silt. 9 units were found to be showing signs of major damage attributable to impact and all remaining 17 units showed signs of minor damage (refer to figure 22).

Observations	Damaged	Slightly Damaged	Good
26	9	17	0

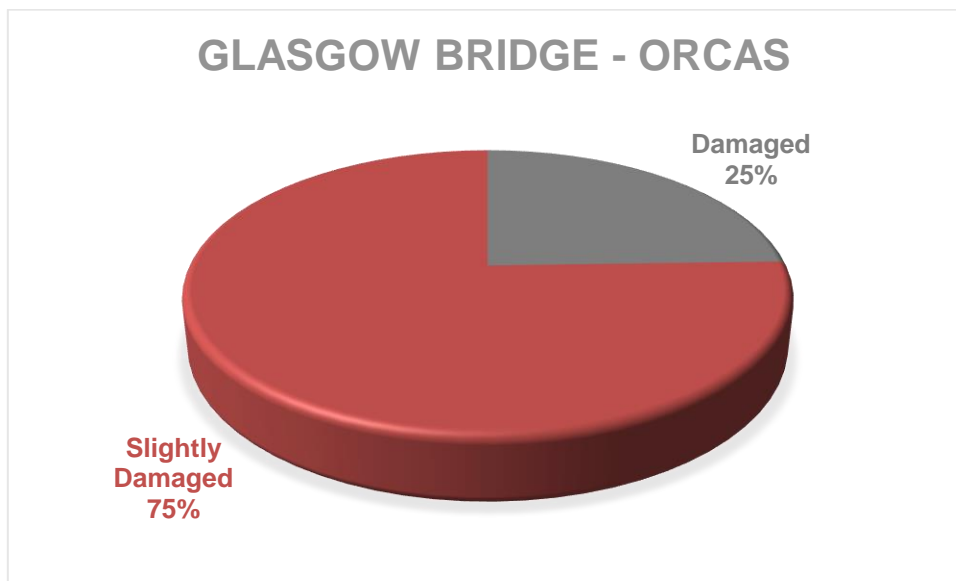
Figure 23: survey results for Orcas on Glasgow Bridge.

A total of 52 units were observed, (refer to figure 24). 53 units were originally installed. 40 Orcas were found to be showing signs of slight damage (refer to figure 25), 12 units were found to be showing signs of major damage, mainly to the top surface area, (refer to figure 26) and 1 unit was missing, (refer to figure 27).

Observations	Damaged	Slightly Damaged	Good
53	13	40	0

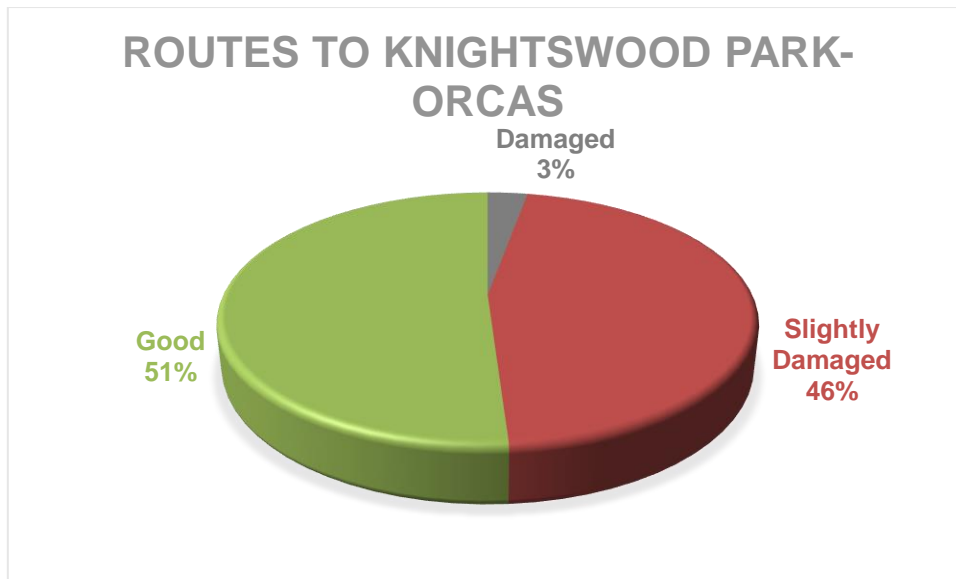
Figure 28: survey results for Orcas along the routes to Knightswood Park.

A total of 381 units were observed. 382 Orcas were originally installed. The vast majority of weepers appeared to be blocked with debris/silt, (refer to figure 29). 176 units were found to be showing signs of minor damage; this included slight or moderate levels of darkened surfaces (refer to figure 30), and tyre marks on the units. Darkened Orcas were observed predominantly under wide-leaf trees, possibly due to limited exposure to sunlight and subsequent effects of increased humidity. 10 Orcas were found to be showing signs of major damage (refer to figure 31); including damage to the top surface, loose or missing bolts and extremely darkened surface (refer to figure 32). 1 Orca was found to be missing on Dyke Road. 195 units were found to be in good conditions.

Observations	Damaged	Slightly Damaged	382
382	11	176	195

It is recommended to investigate means to cleanse the surface of Orcas especially those installed under trees and to include the Routes to Knightswood in GCC's new Multihog 'Cleansing and de-icing' programme in order to remove foliage from the cycleway which increase blockage of weep holes on soft segregation products.

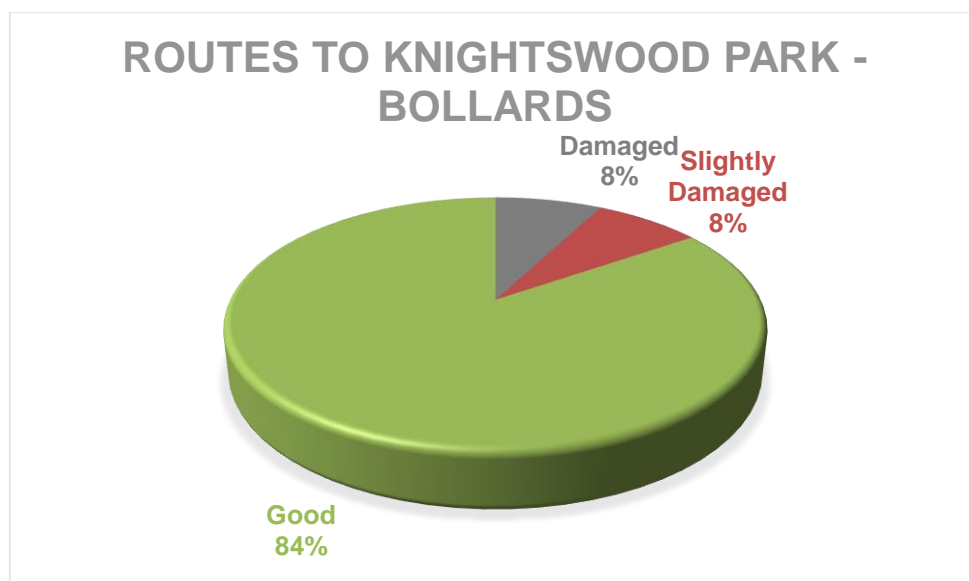
Figure 33: survey results for Passively Safe Impact Bollards along the routes to Knightswood Park.

A total of 26 units were observed. This number coincides with the number of units originally installed. 2 bollards were damaged (refer to figures 34 & 35), 2 units were slightly damaged (refer to figure 36) and 22 bollards were found to be in good conditions (refer to figure 37).

Observations	Damaged	Slightly Damaged	Good
26	2	2	22

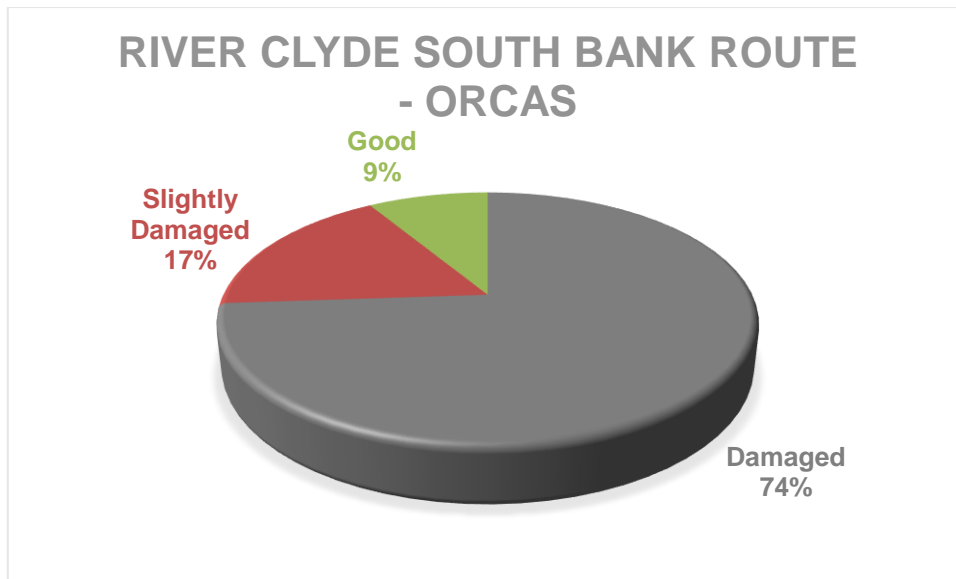
Figure 38: survey result for Orcas on the River Clyde South Bank Route.

A total of 20 Orcas were observed. 23 Orcas were originally installed. The vast majority of weepers appeared to be blocked with debris/silt, (refer to figure 39). 4 units were found to be showing signs of minor damage; this included slight or moderate levels of darkened surfaces and tyre marks on the unit (refer to figure 40). 14 Orcas were found to be showing signs of major damage; including damage to the top surface and loose or missing bolts (refer to figure 41). 3 Orcas were found to be missing (refer to figure 42) and 2 units were found to be in good conditions.

Observations	Damaged	Slightly Damaged	Good
23	17	4	2

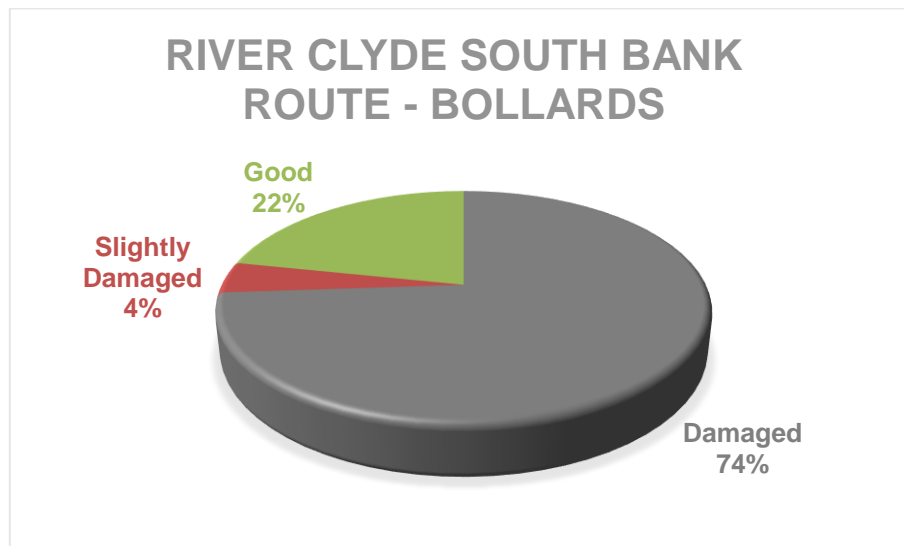
Figure 43: survey results for Passively Safe Impact Bollards on the River Clyde South Bank Route.

A total of 17 units were observed. 23 units were originally installed. 11 bollards were damaged (refer to figure 44); including displaced bollards and units with loose or missing bolts, (refer to figure 45). 6 units were missing, 1 unit was slightly damaged and 5 bollards were found to be in good conditions (refer to figure 46).

Observations	Damaged	Slightly Damaged	Good
23	17	1	5

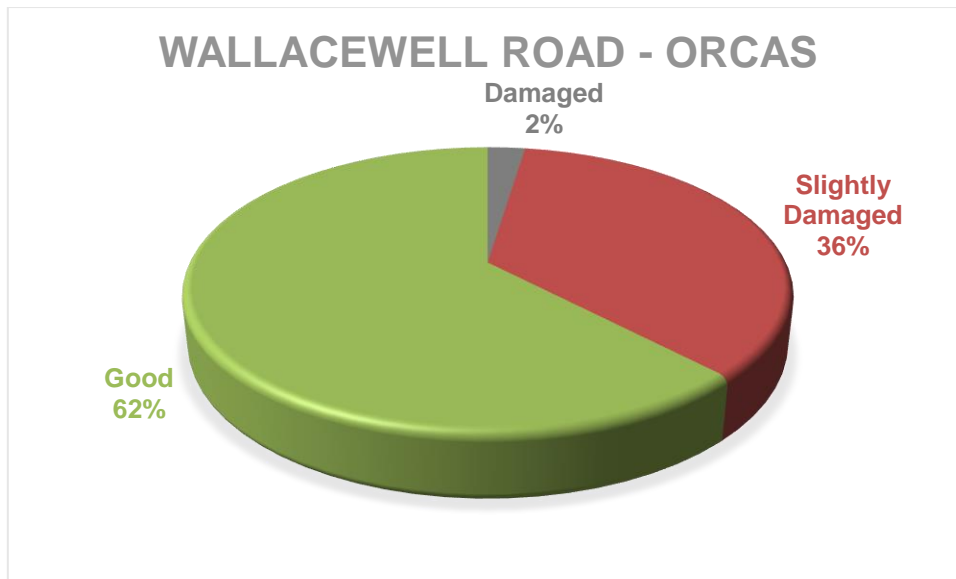
Figure 47: survey results for Orcas on Wallacewell Road.

A total of 209 Orcas were observed. This number coincides with the number of units originally installed. The vast majority of weepers appeared to be blocked with debris/silt, (refer to figure 48). 74 units were found to be showing signs of minor damage; this included slight or moderate levels of darkened surfaces and tyre marks on the unit (refer to figure 49). 5 Orcas were found to be showing signs of major damage; including damage to the top surface, extreme darkening and loose or missing bolts (refer to figure 50). 130 Orcas were found to be in good conditions.

Observations	Damaged	Slightly Damaged	Good
209	5	74	130

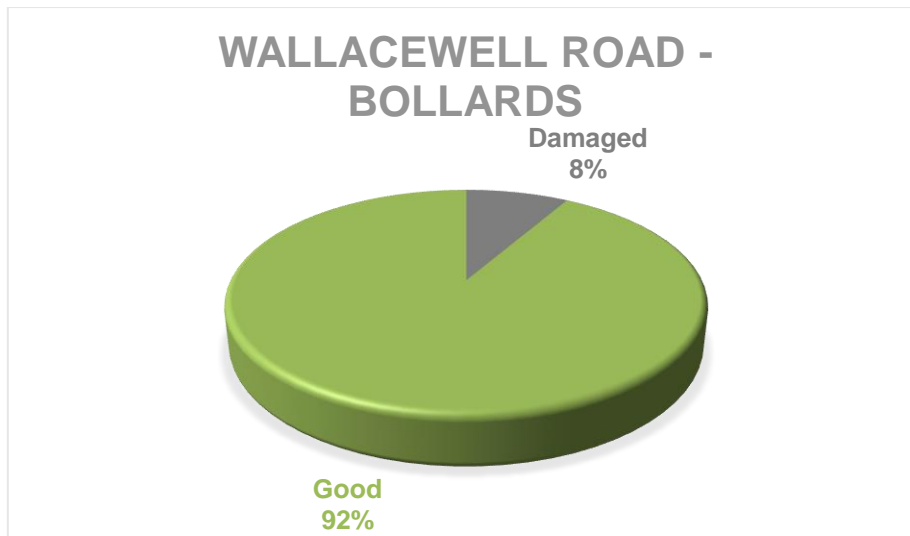
Figure 51: survey results for bollards on Wallacewell Road.

A total of 12 units were observed. This number coincides with the number of units originally installed. 1 bollard was damaged (refer to figure 52) and 11 bollards were found to be in good conditions.

Observations	Damaged	Slightly Damaged	Good
12	1	0	11

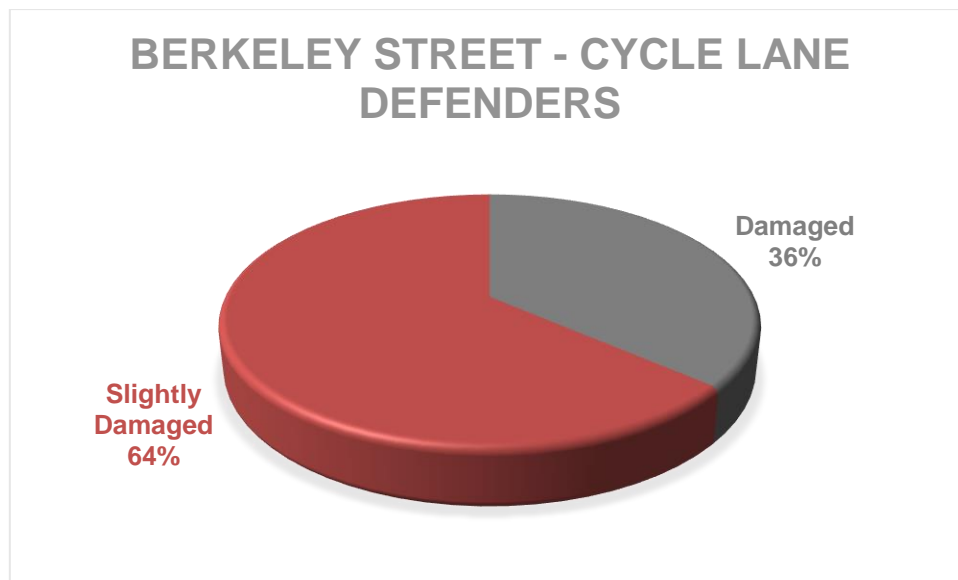
Figure 53: survey results for cycle lane Defenders on Berkeley Street.

A total of 11 units were observed. This number coincides with the number of units originally installed. 4 Defenders were damaged (refer to figure 54) and 7 Defenders were found to be slightly damaged (refer to figure 55), mainly as a consequence of the reflective strips peeling off and minor deterioration to the surface due to impact.

Observations	Damaged	Slightly Damaged	Good
11	4	7	0
